# Tank 5 HISTORY

Poster Station #2  
3 Posters  
March 14, 2018

## ***Tank 5 Fuel Release Was Caused By Human Error, Not Corrosion***

### **TANK 5 RELEASE**

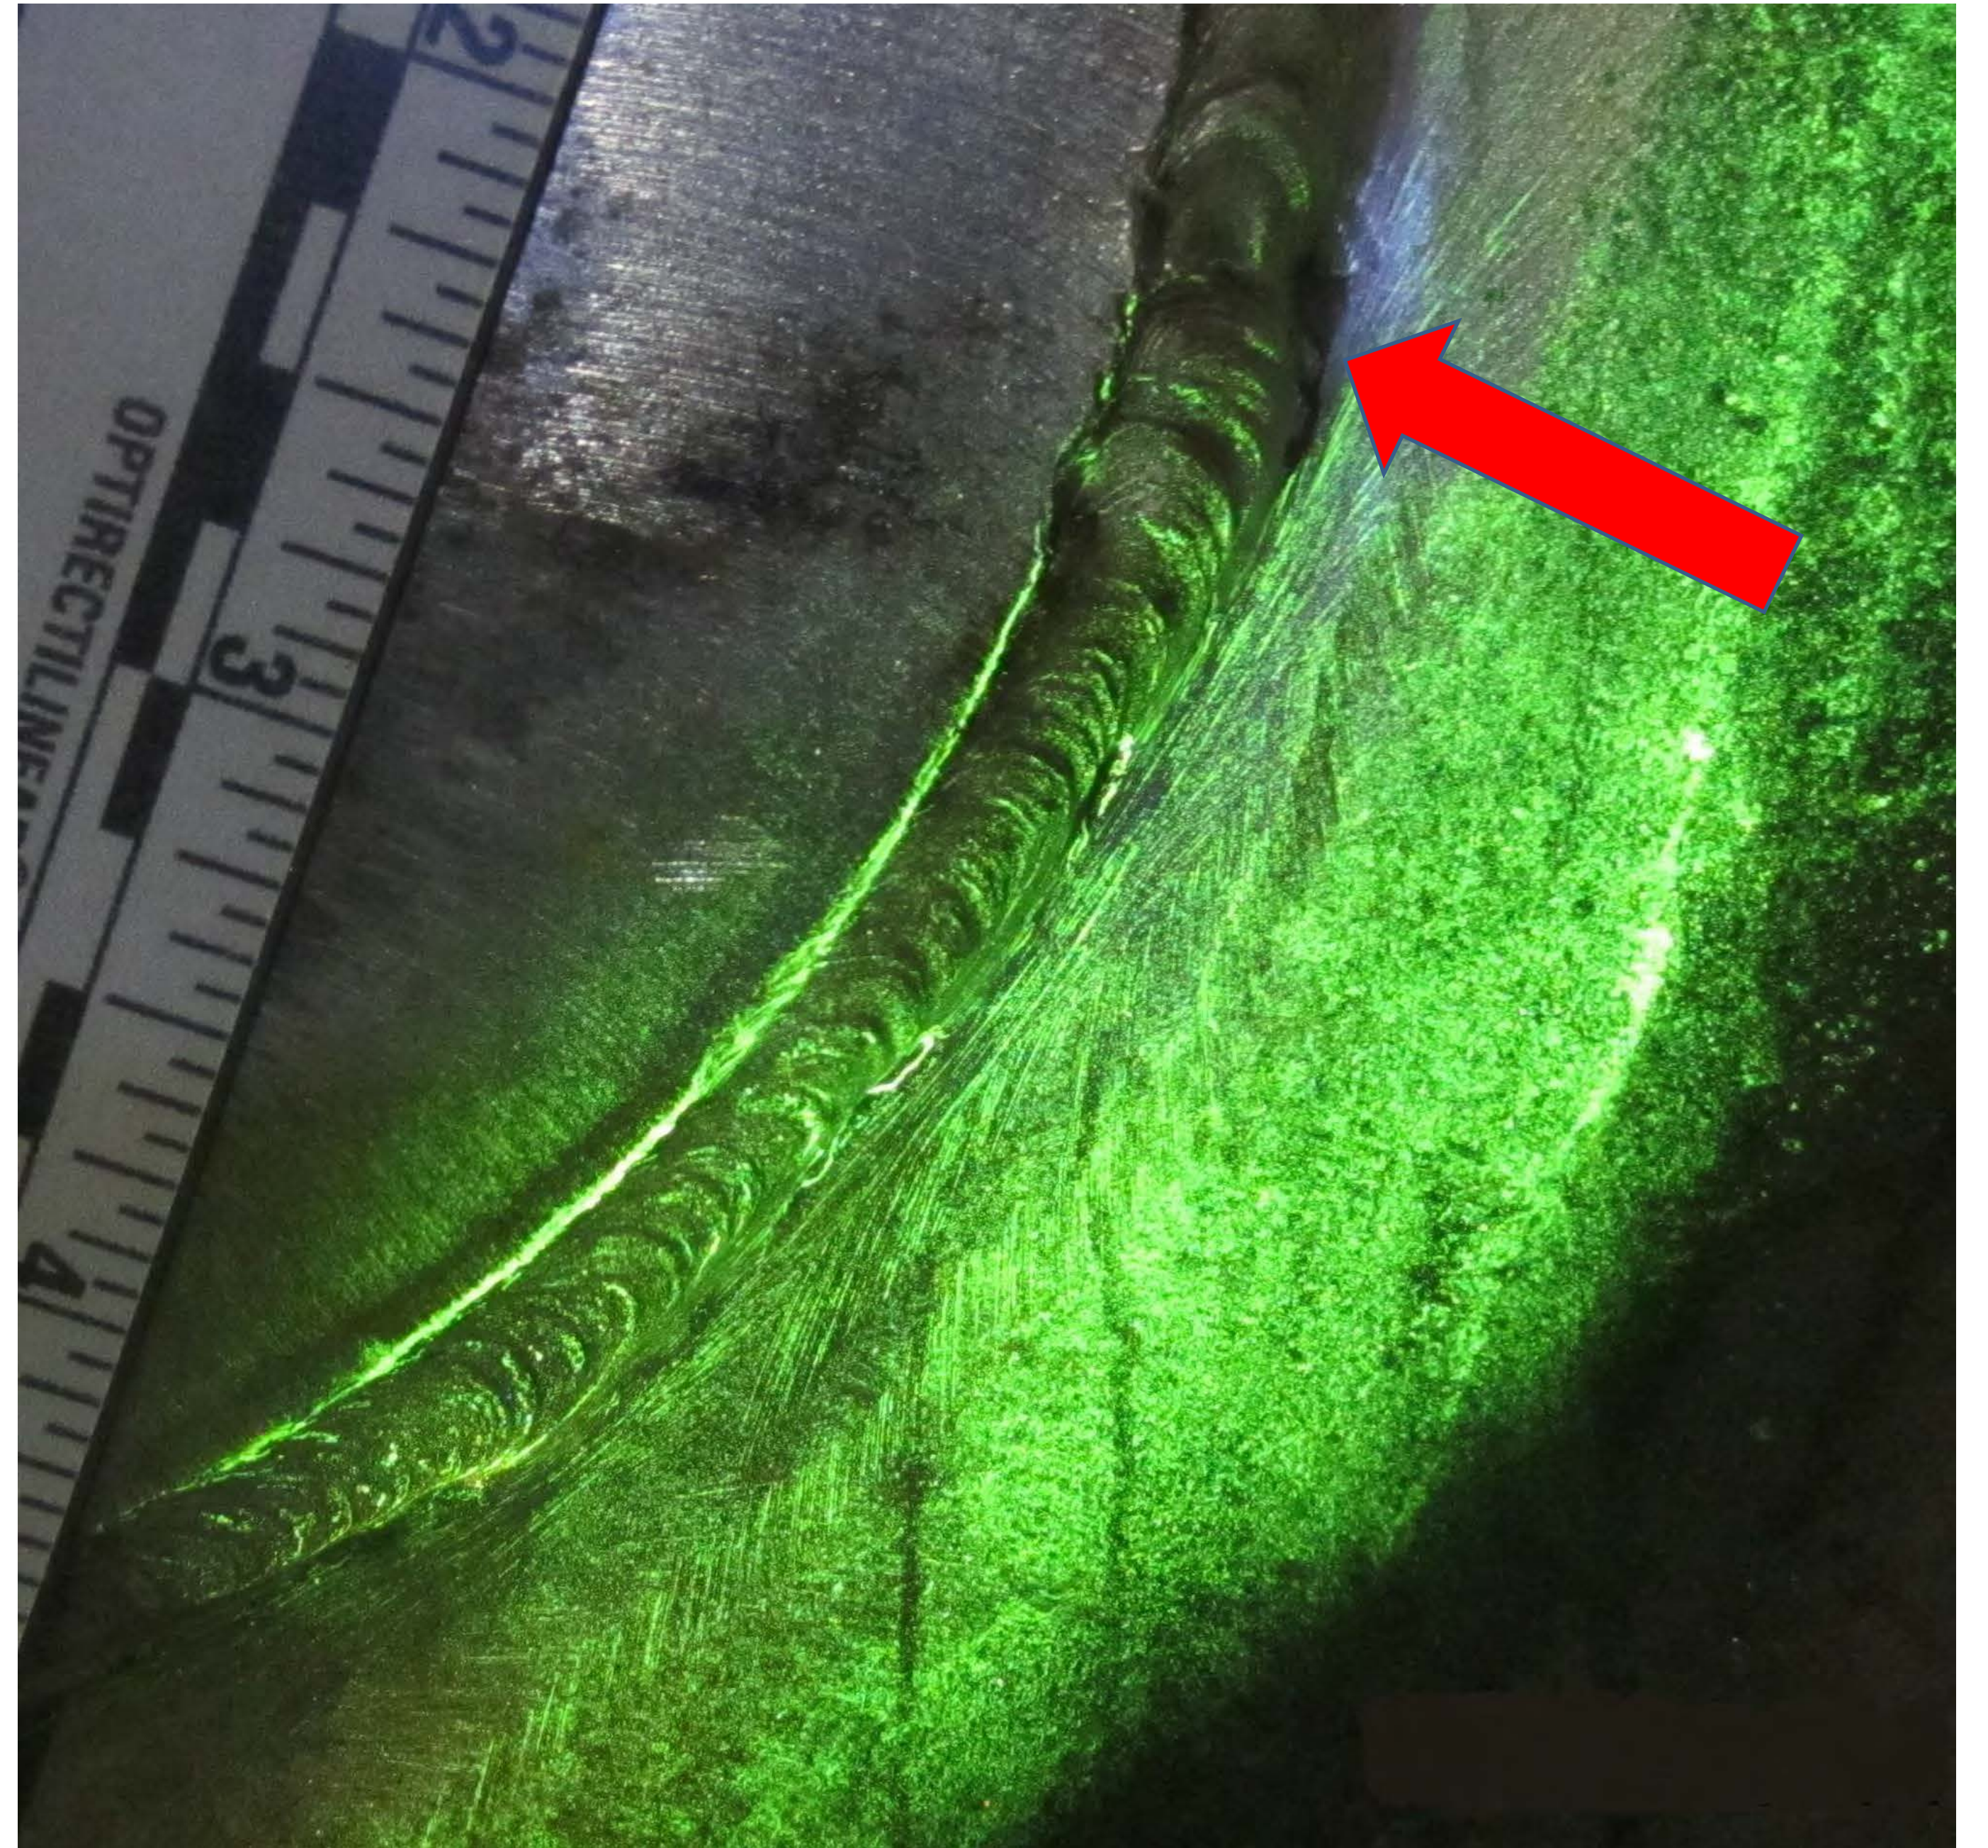
- Tank 5 Passed The Biennial Leak Detection Test 29 June 2009, No Leaks
- Tank 5 Defueled For a Three-year Inspection and Repair Project, 1 Oct 2009
- Contractor Improperly Repaired Tank 5
- An API Inspector Certified Tank 5 Suitable for Service
- Navy Detected a Discrepancy, “Unscheduled Fuel Movement” 12 Jan 2014
- Release Was Reported To Regulators 13 Jan 2014

- Poor Workmanship – Defective Welding Was Ineffective
- Contractor Quality Control
- Insufficient Navy Quality Assurance
- Tank 5 Was Incorrectly Certified “Suitable for Service”
- Government Failed To Acknowledge Alarms While Filling Tank

- Development of Tank Inspection and Tank Repair Specifications
  - Requires Improved Contractor Quality Control
  - Improved Standard of Care for Inspection and Repair
- Improved Navy Quality Assurance Process
- New Filling and Return to Service Instruction
- Tank 5 Was Completely Reinspected in 2017

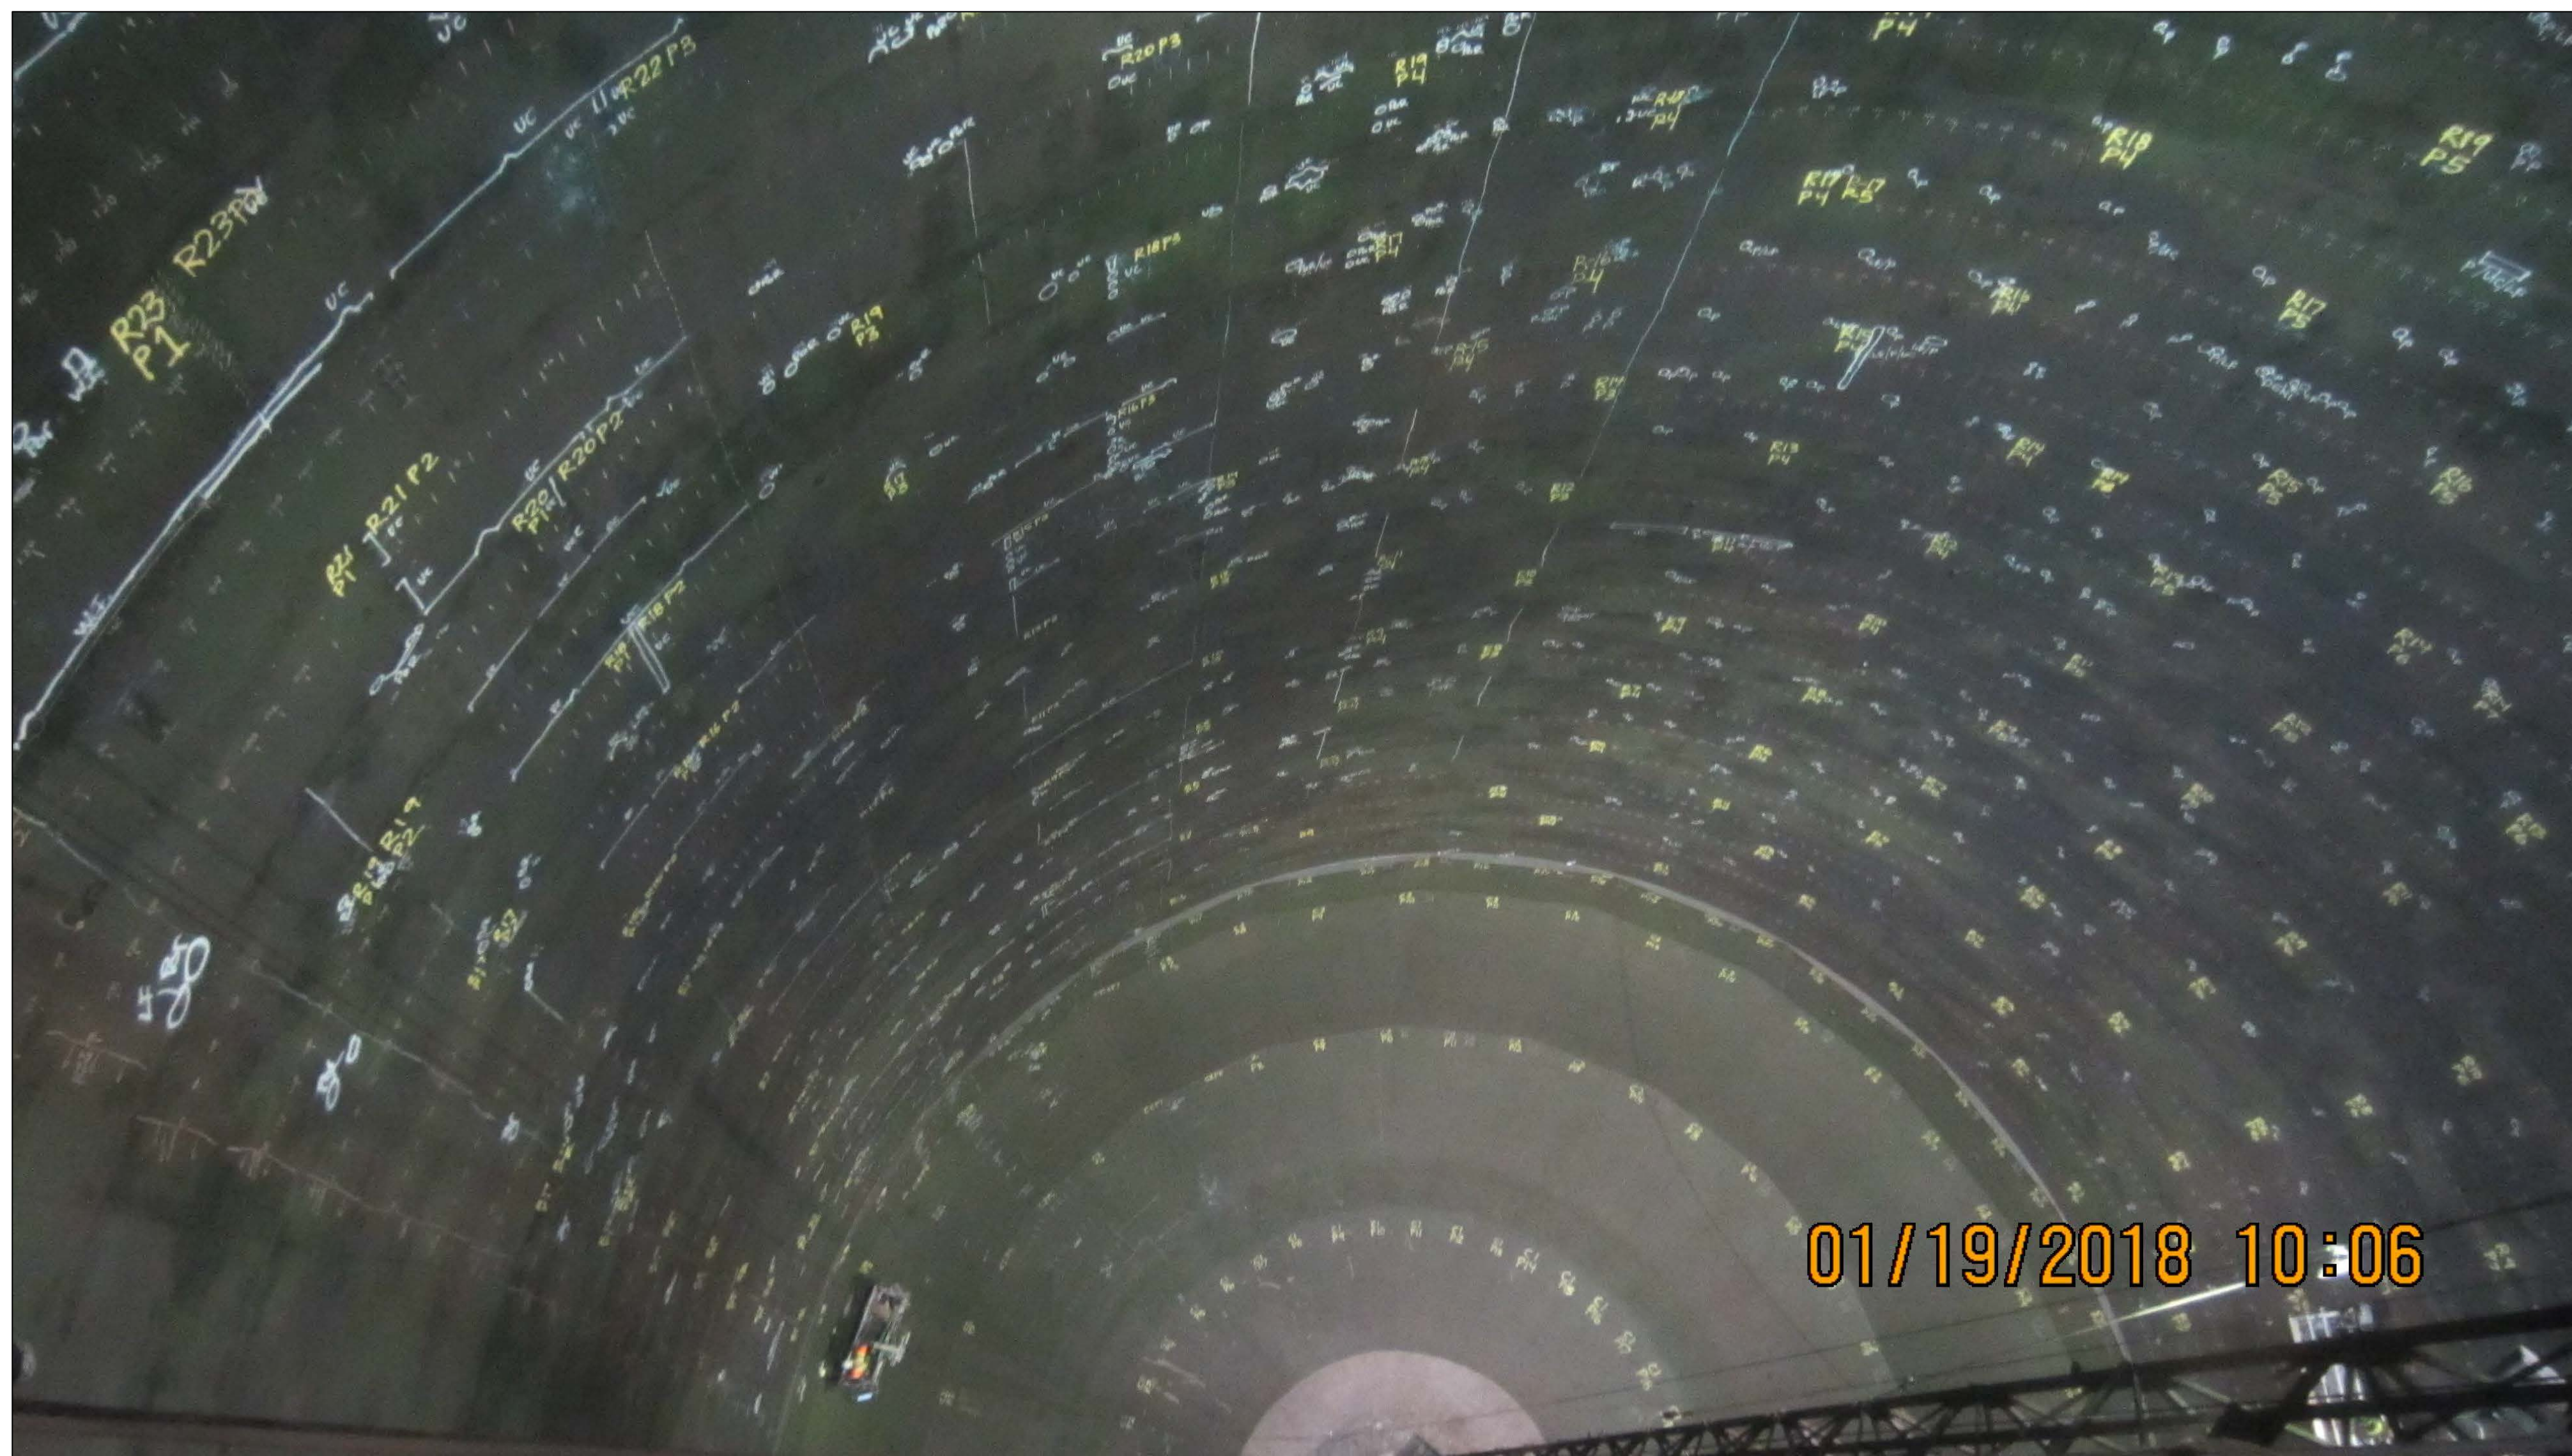
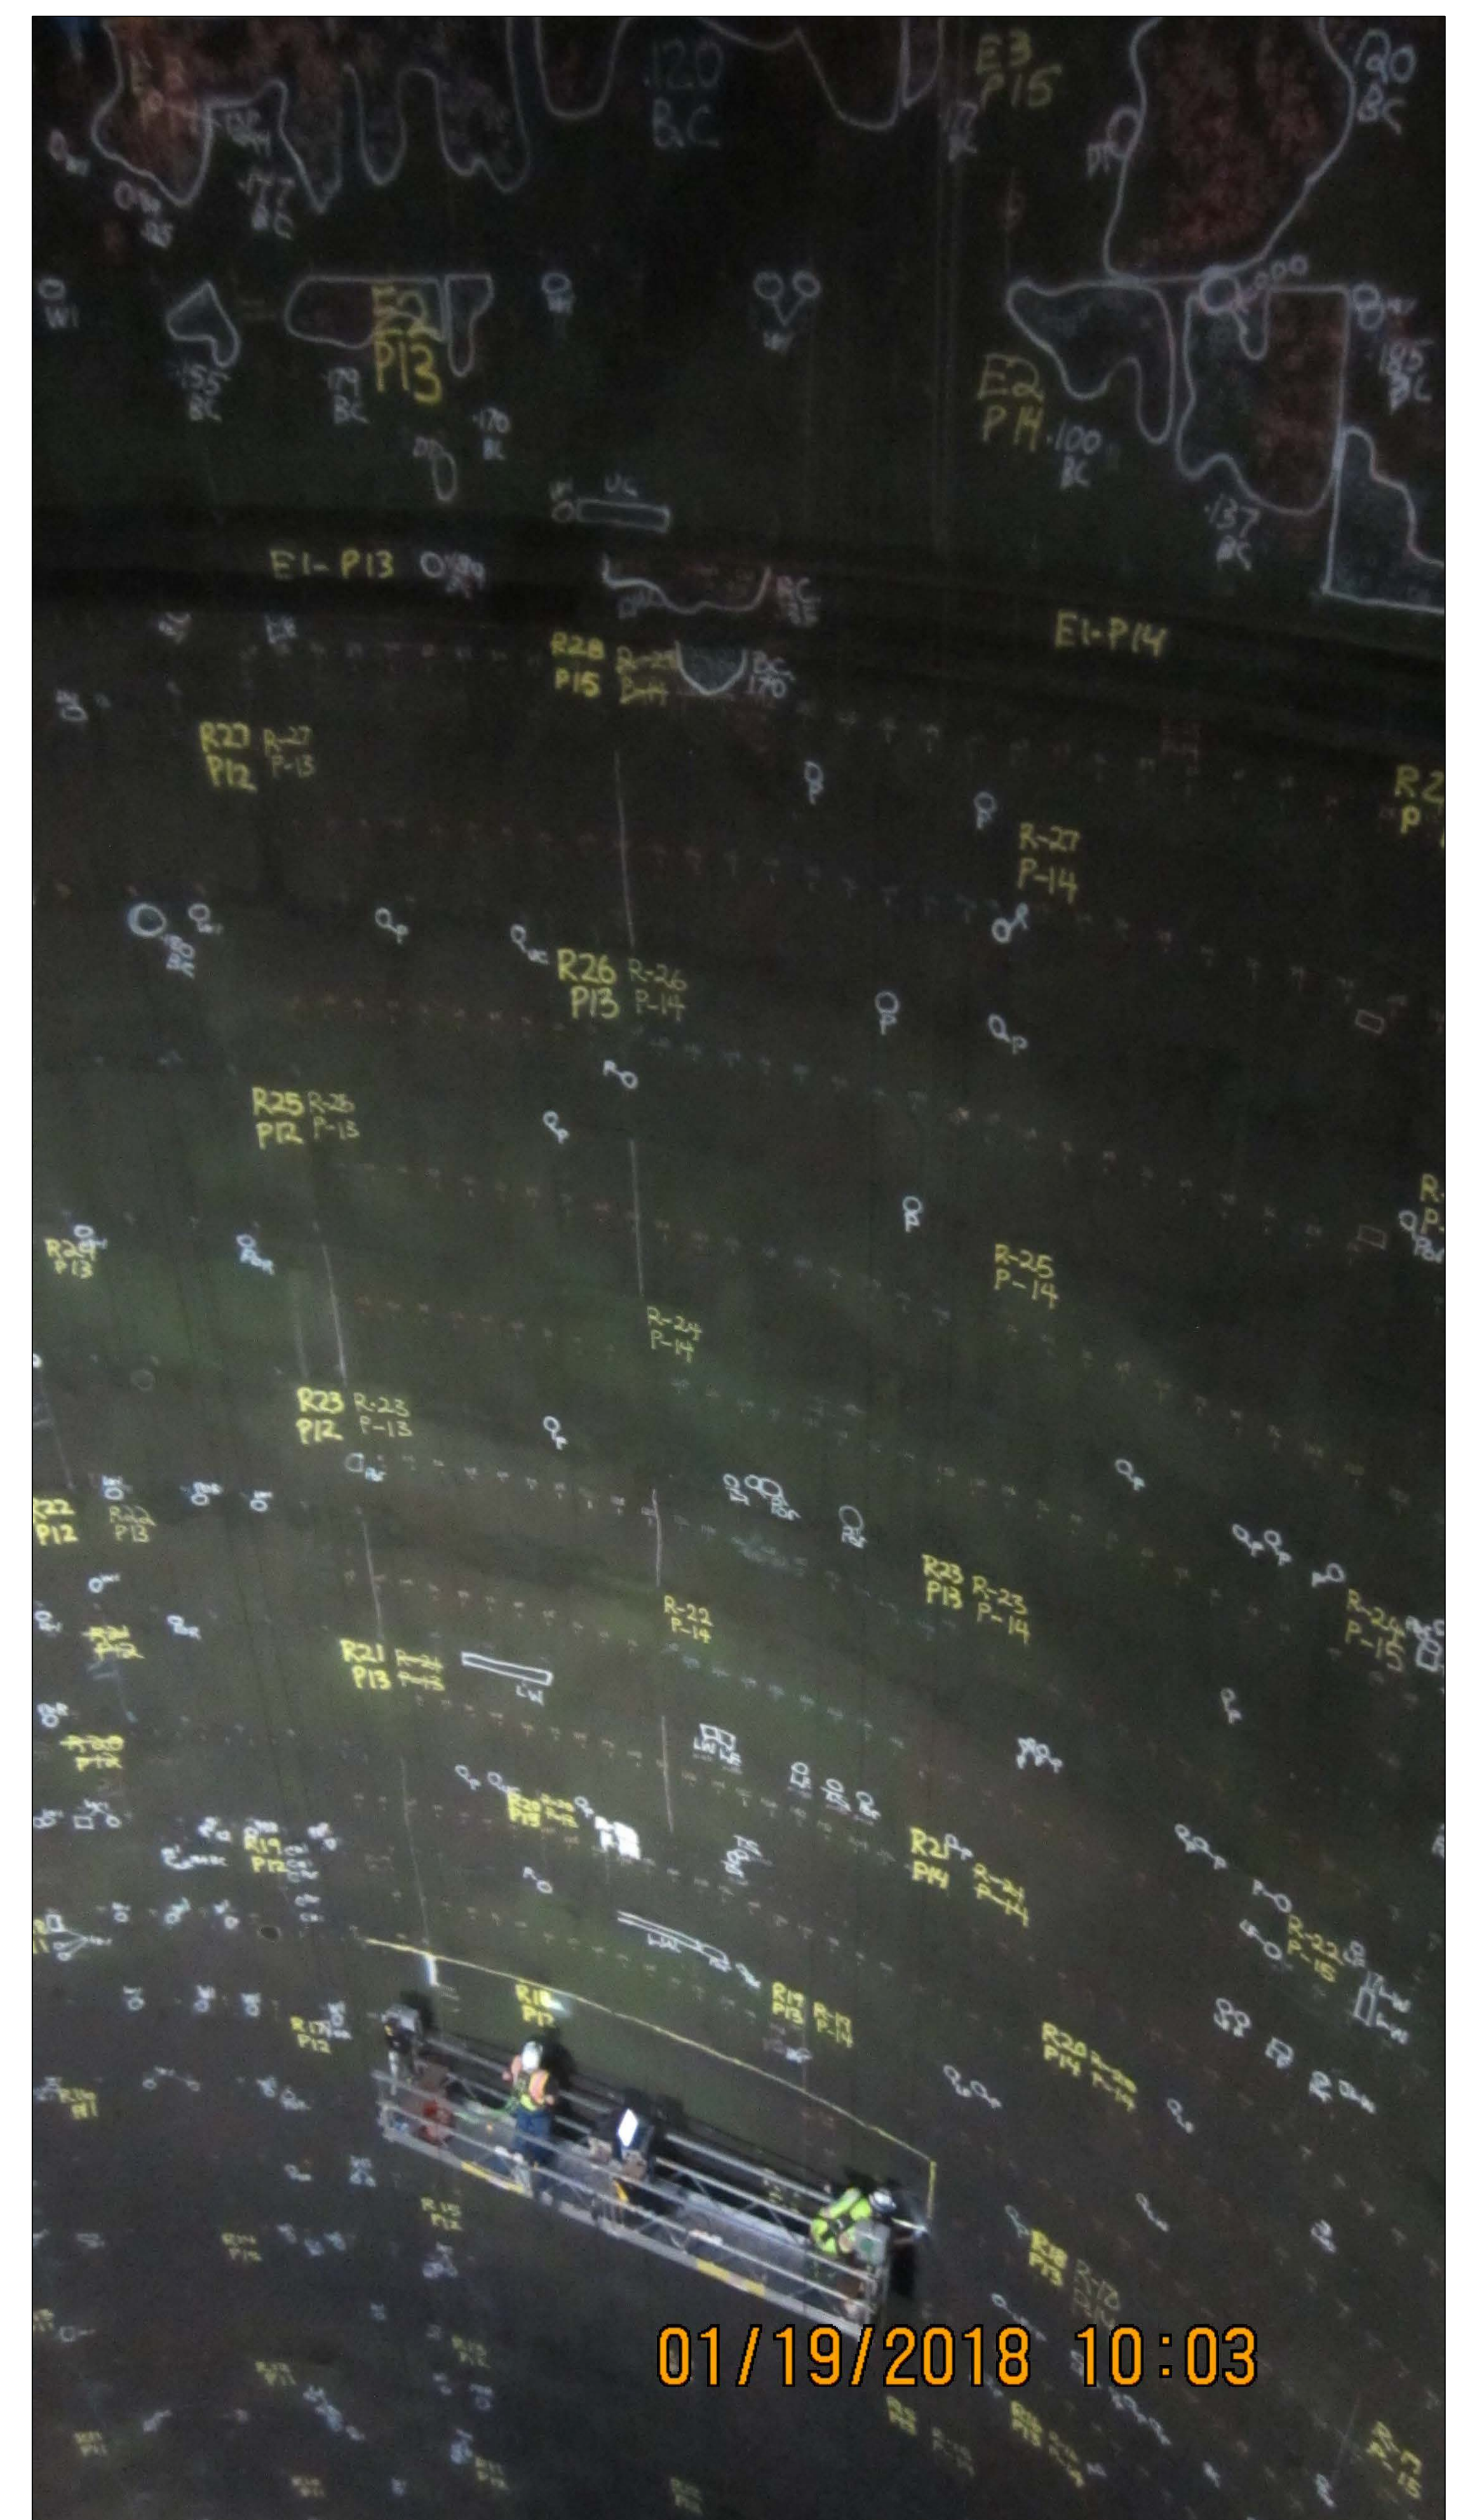
*Tank 14 mapping grid employed for a current API653 inspection. (above/right)*

**Detailed marking of a tank allows for a more precise/thorough inspection. This results in higher quality control and quality assurance.**
