Underground Storage Tank System Inspection Report

Bulk Fuel Storage Systems Including Red Hill and the Airport Hydrant System Serving Joint Base Pearl Harbor-Hickam

August 17, 2022

US EPA REGION 9 UNDERGROUND STORAGE TANK INSPECTION REPORT

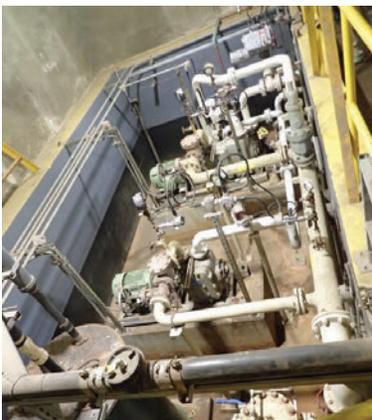
The UST inspection team identified two sumps in the lower tunnel (Main Containment Sump for Fuel Oil Reclamation and Zone 7 Sump for Fuel Oil Reclamation), see photos below, that were not included in the Navy's May 15, 2019, UST permit application submitted to HDOH (Attachment K). These sumps meet the definition of a "Tank," because they are stationary devices designed to contain an accumulation of regulated substances and constructed of non-earthen materials (e.g., concrete, steel, plastic) that provide structural support, per HAR § 11-280.1-12. The volumetric capacities of the two sumps were undetermined at the time of the inspection. The Navy was unable to demonstrate that these two USTs were in compliance with the tank tightness testing and other UST requirements.

Figure 1: Main Containment Sump for Fuel Oil Reclamation

2.	Release detection recordkeeping: HAR § 11-280.1-45(2) [40 CFR § 280.34(b)] <i>All UST system owners and</i>	Release detection records were not available for two USTs in the lower tunnel (the the Main Containment Sump for Fuel Oil	Attachment A: JBPHH Facility EPA R9 UST Inspection Checklist

AON	Regulatory Citation(s)	Findings / Supporting Notes	Evidence / References
	<p><i>operators must maintain records in accordance with section 11-280.1-34 demonstrating compliance with all applicable requirements of this subchapter.</i></p>	<p>Reclamation and Zone 7 Sump for Fuel Oil Reclamation).</p> <p>Release detection records were also not available for the PRTs at Diamond Head and Ewa Tanks.</p>

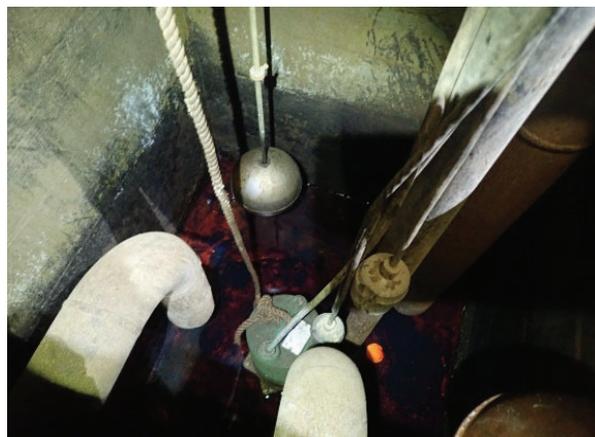
Figure 2: Zone 7 Sump for Fuel Oil Reclamation
