**Demolish JP-5 Slop Tank at the Red Hill Fuel Facility
Fleet and Industrial Supply Center
Pearl Harbor, Hawaii**

Technical Report

Project No. P-035090-07/PRL 07-16

Revision 0

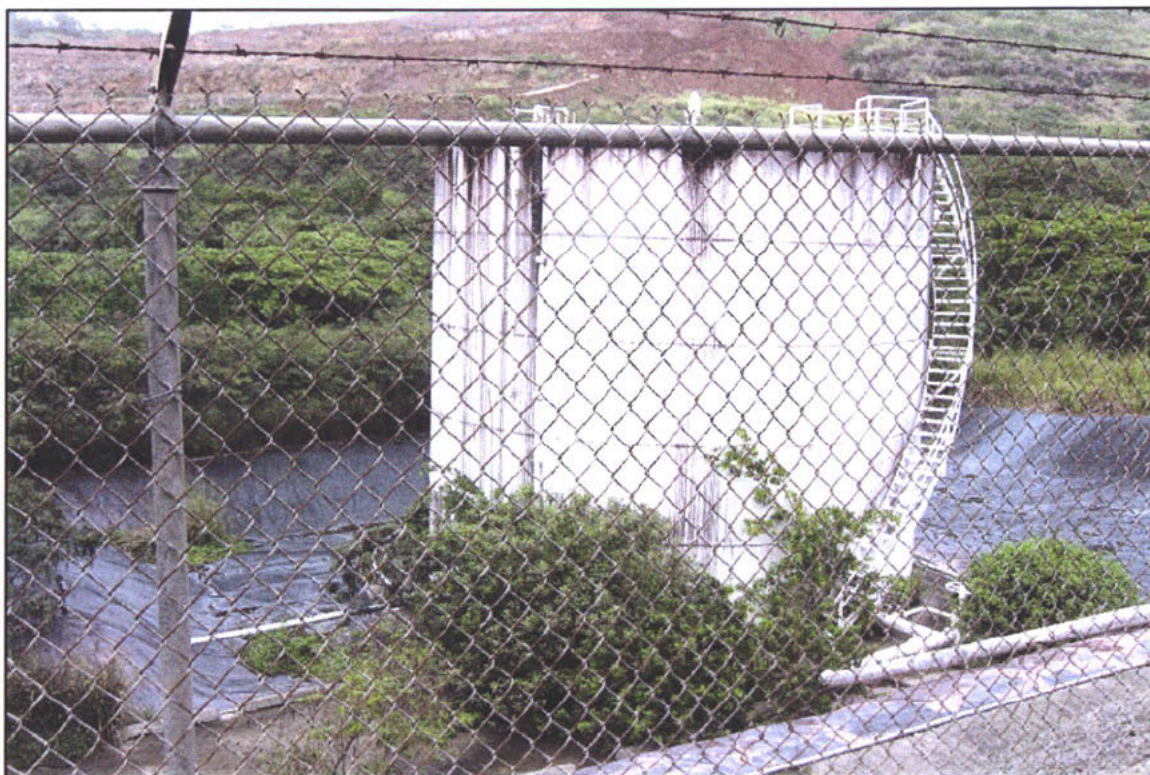
Photo No. 1: JP-5 Slop Tank S-355 prior to demolition

The tank, tank staircase, and piping were demolished using an excavator with hydraulic shears. The concrete ring wall and sidewalk around the tank were demolished. Crusher run base material under the tank was sampled and analyzed. Results, presented in Appendix C, indicate the level of total petroleum hydrocarbons (TPH) as JP-5 in the crusher run is below HDOH reporting limits; therefore, the crusher run was left in place.

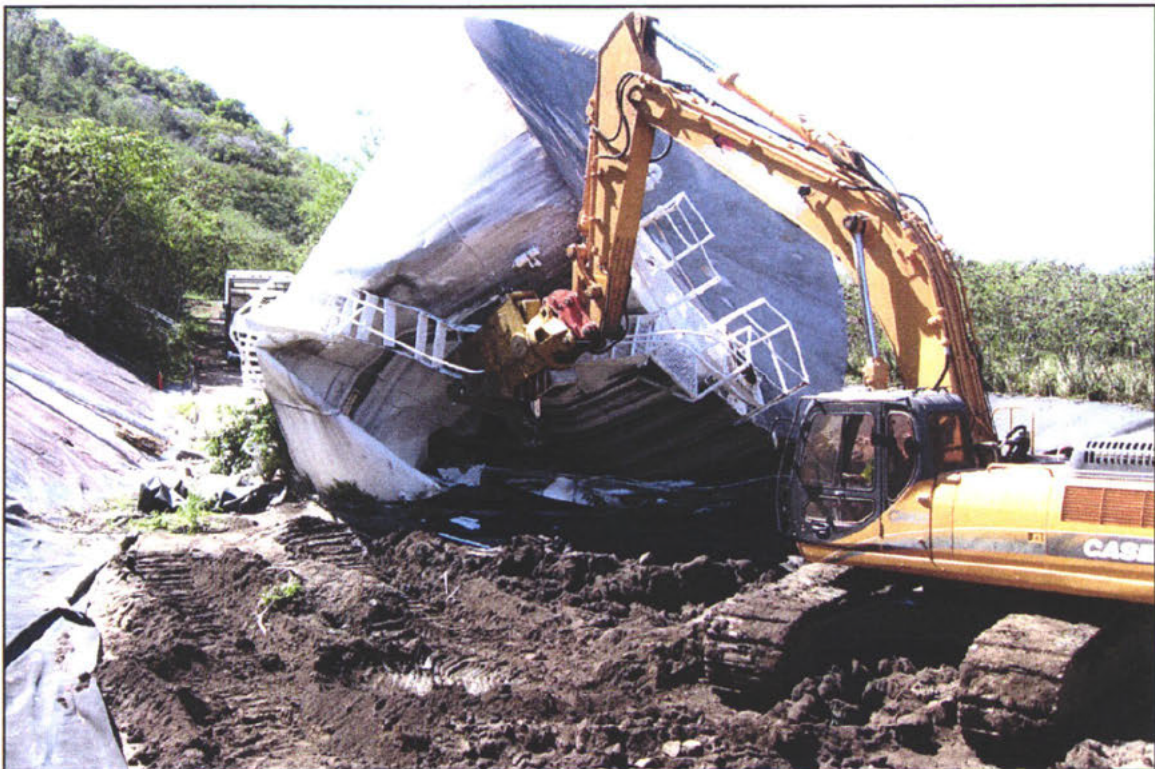
Photo No. 6: Tank demolition in progress.

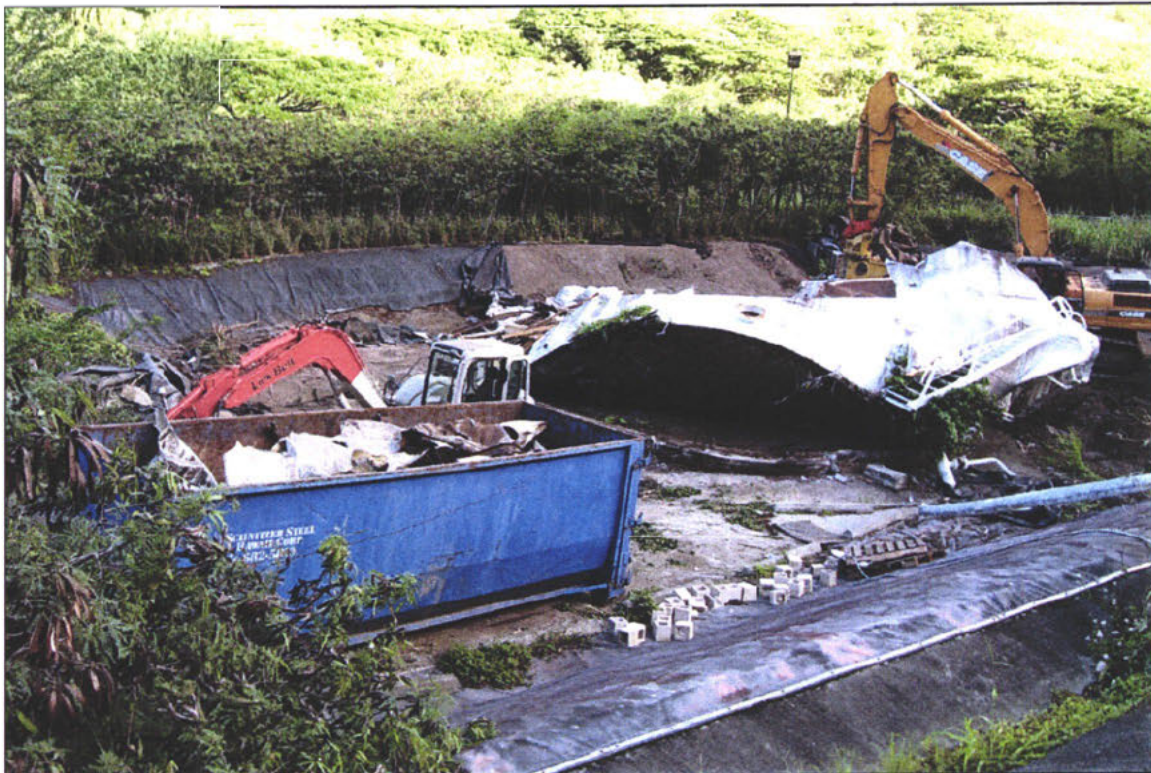
Photo No. 7: Metal loaded into recycling bins.

All demolished metal, including tank, piping, valves, and pumps, were taken to an on-island metal recycler.

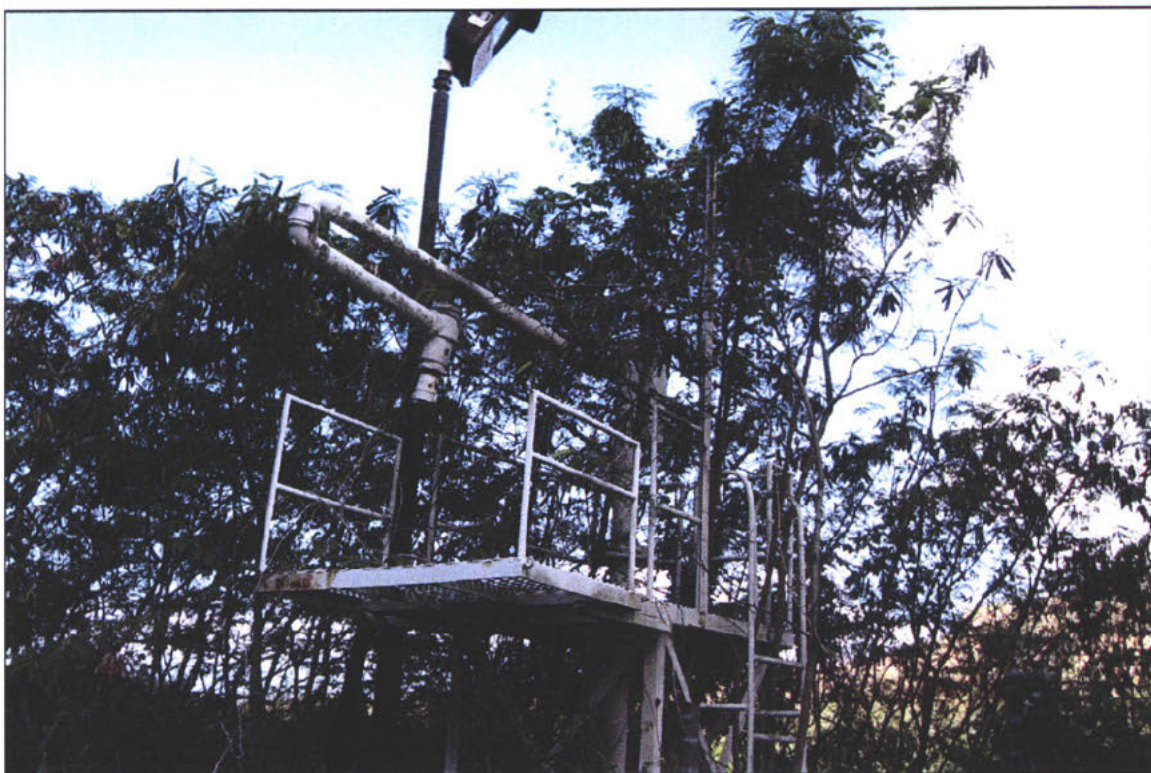
Photo No. 8: Truck-loading rack.

Outside of the berm and along the road, the truck-loading rack, staircase, lighting fixture, and aqueous film-forming foam tank were dismantled and removed.

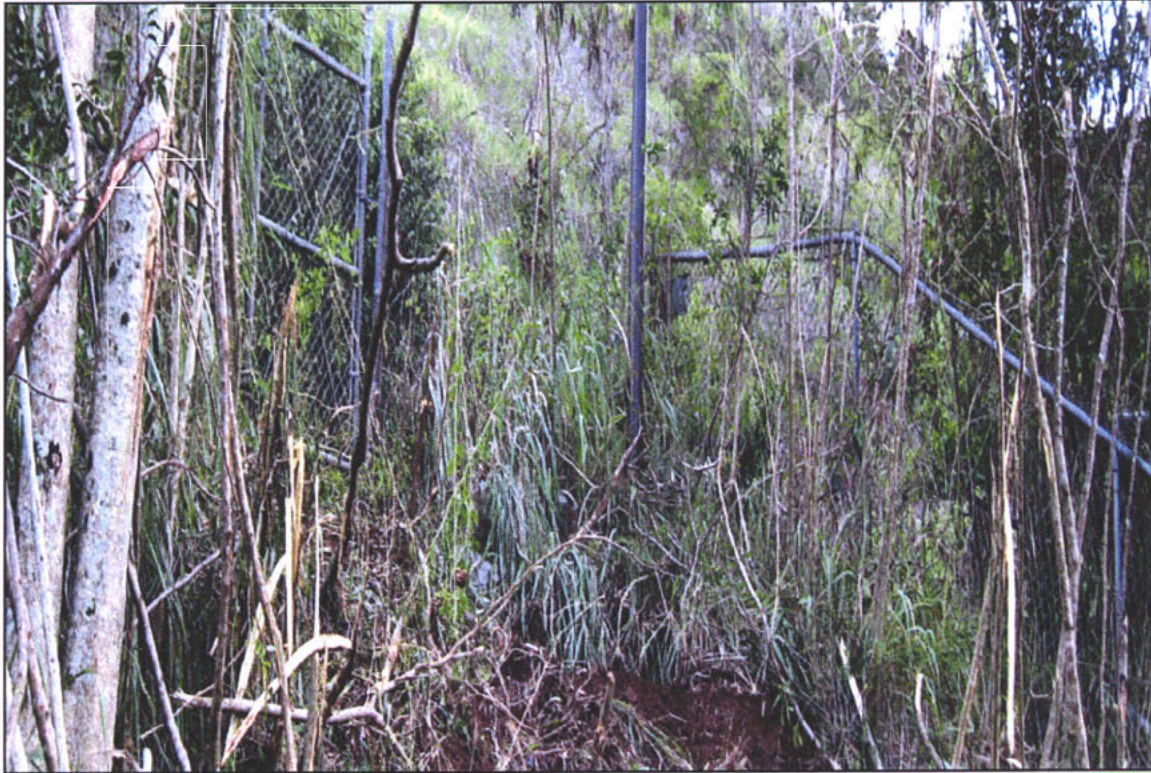
Photo No. 9: Truck rack removed; up-slope view.

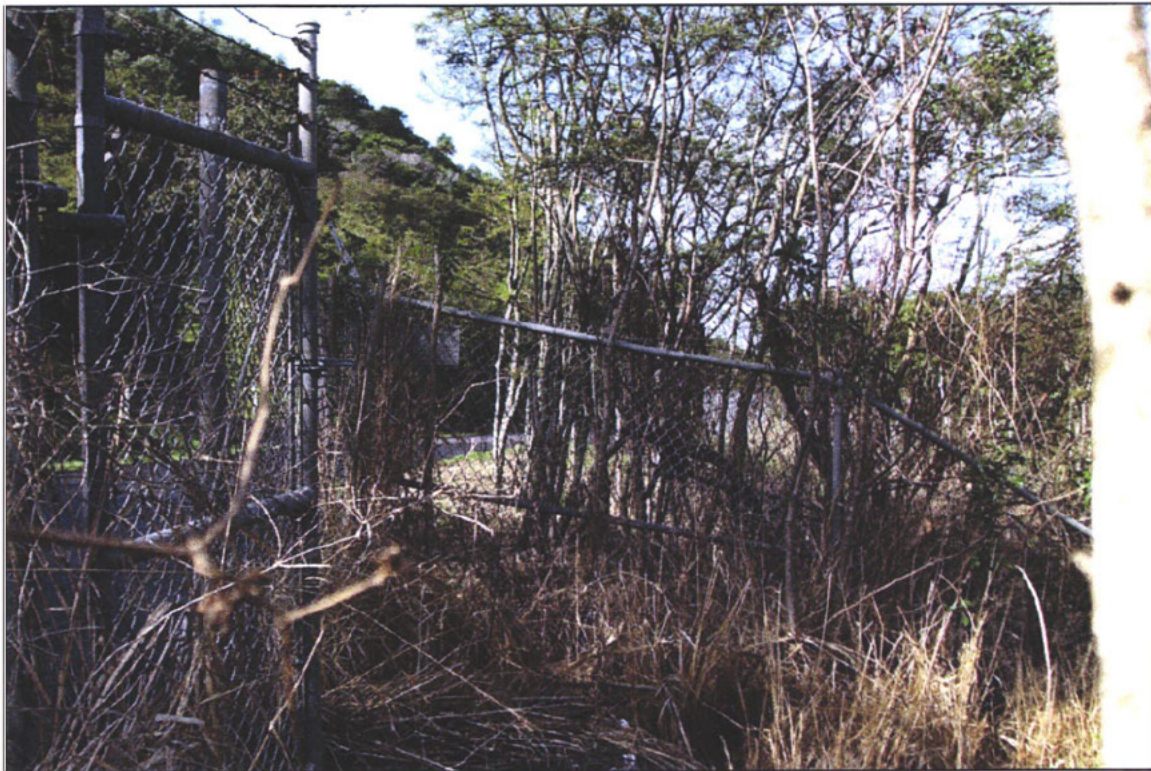
Photo No. 10: Truck rack and light post removed - corner view.

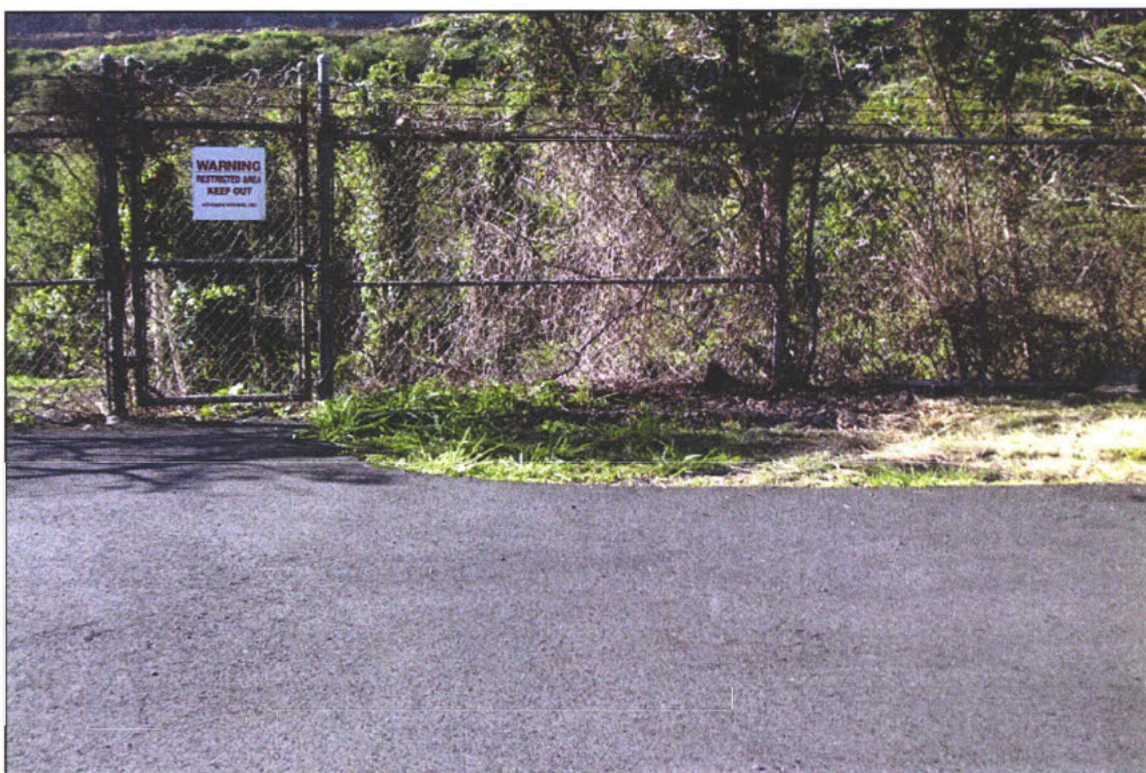
Photo No. 12: Aqueous film-forming foam tank removed after demolition.

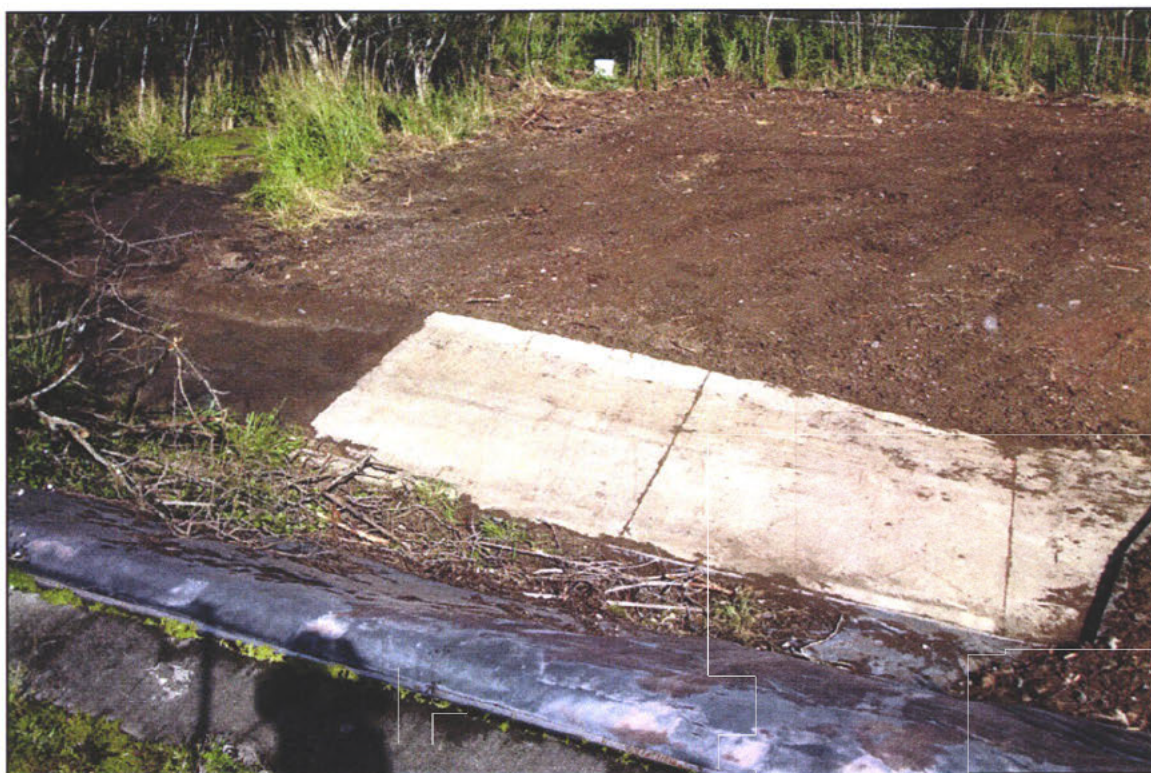
Photo No. 14: Photo shows completion on the left side of the driveway.

Re-distribution of the soil berm was achieved by using bladed hydraulic hoe equipment to spread soil across the site. The material was re-distributed to create a swale at the base of the driveway which will allow drainage of the area and prevent ponding of rain runoff.

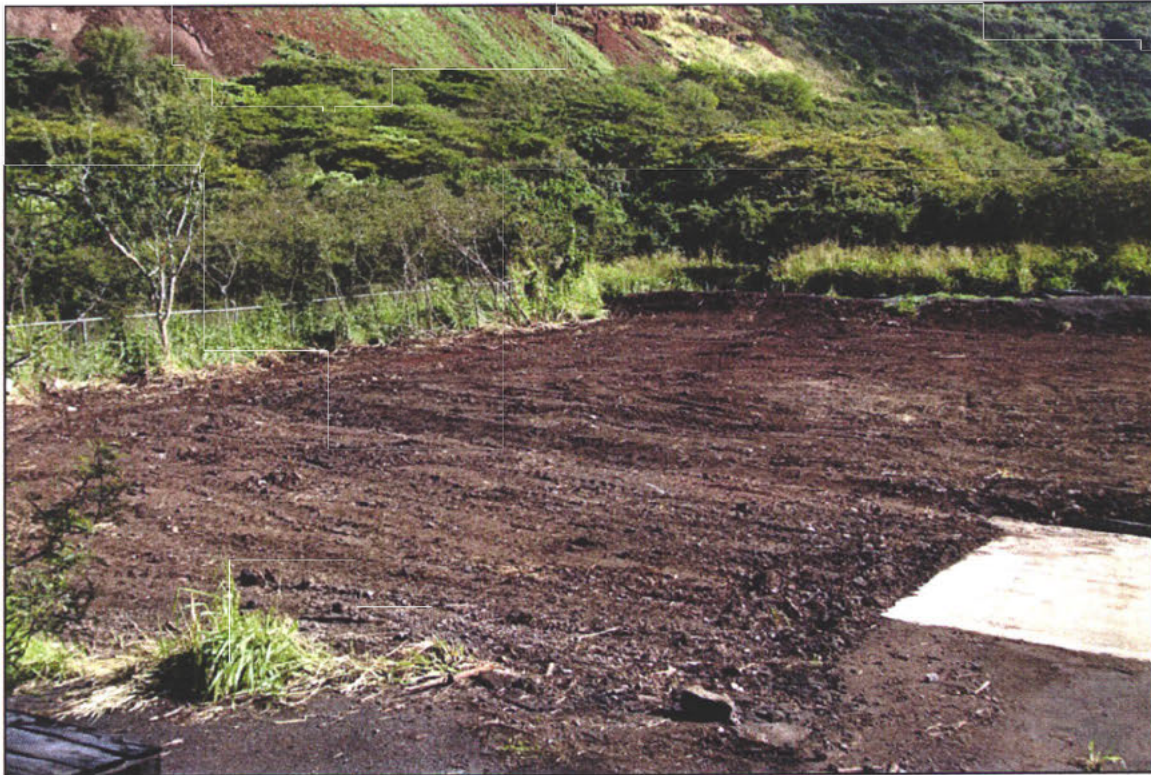
Photo No. 15: Middle view of the site from the driveway.

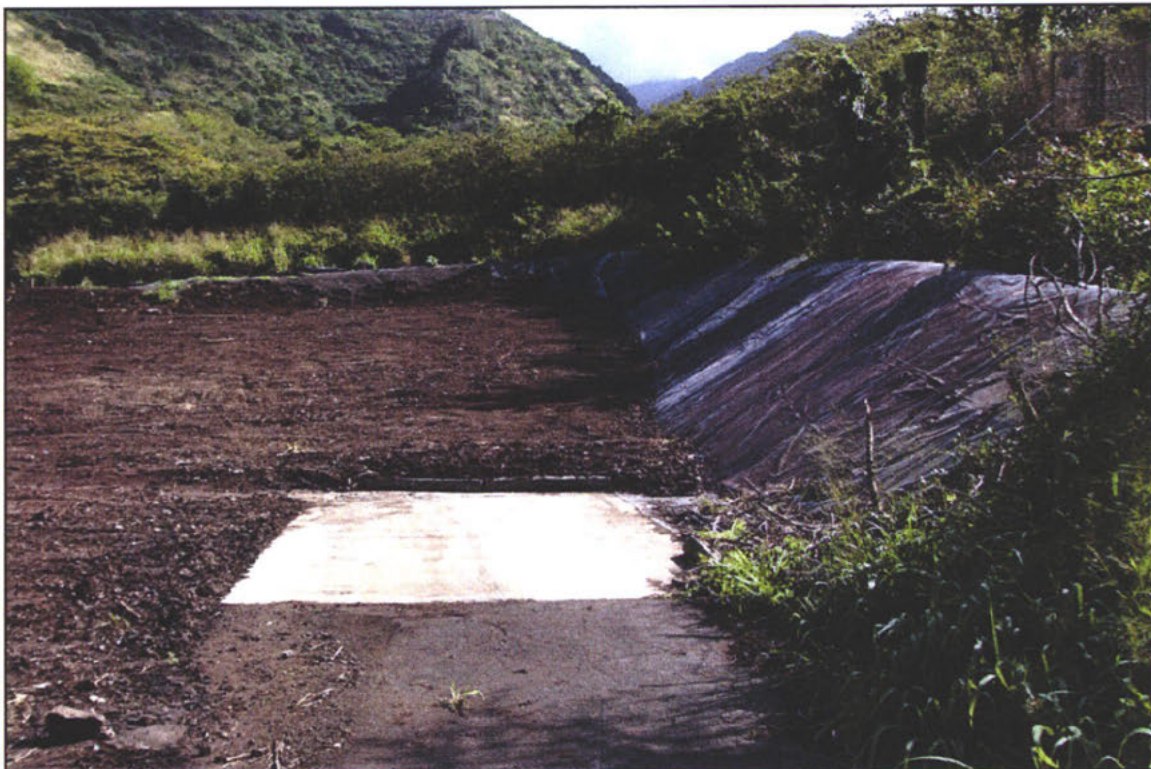
Photo No. 16: View of the site from the driveway gate.
