Subj: SAMPLING AND TESTING FOR LEAD IN DRINKING WATER AT NAVY HALE KEIKI

## Overview of Testing Results and Corrective Actions for Navy Hale Keiki (Building 366)

**LIPA Test Results**  
**JBPHH - Navy Hale Keiki (Building # 364-368 & 407)**

DATE: <b>DEC 2019</b>	PROJECT TITLE: LEAD IN DRINKING WATER TESTING AT PRIORITY AREAS AT JBPHH AND NCTAMS, PACIFIC
	FIGURE TITLE: PEARL HARBOR, NAVY HALE KEIKI (BLDG 364 - 368 & 407) - OVERALL FACILITY MAP

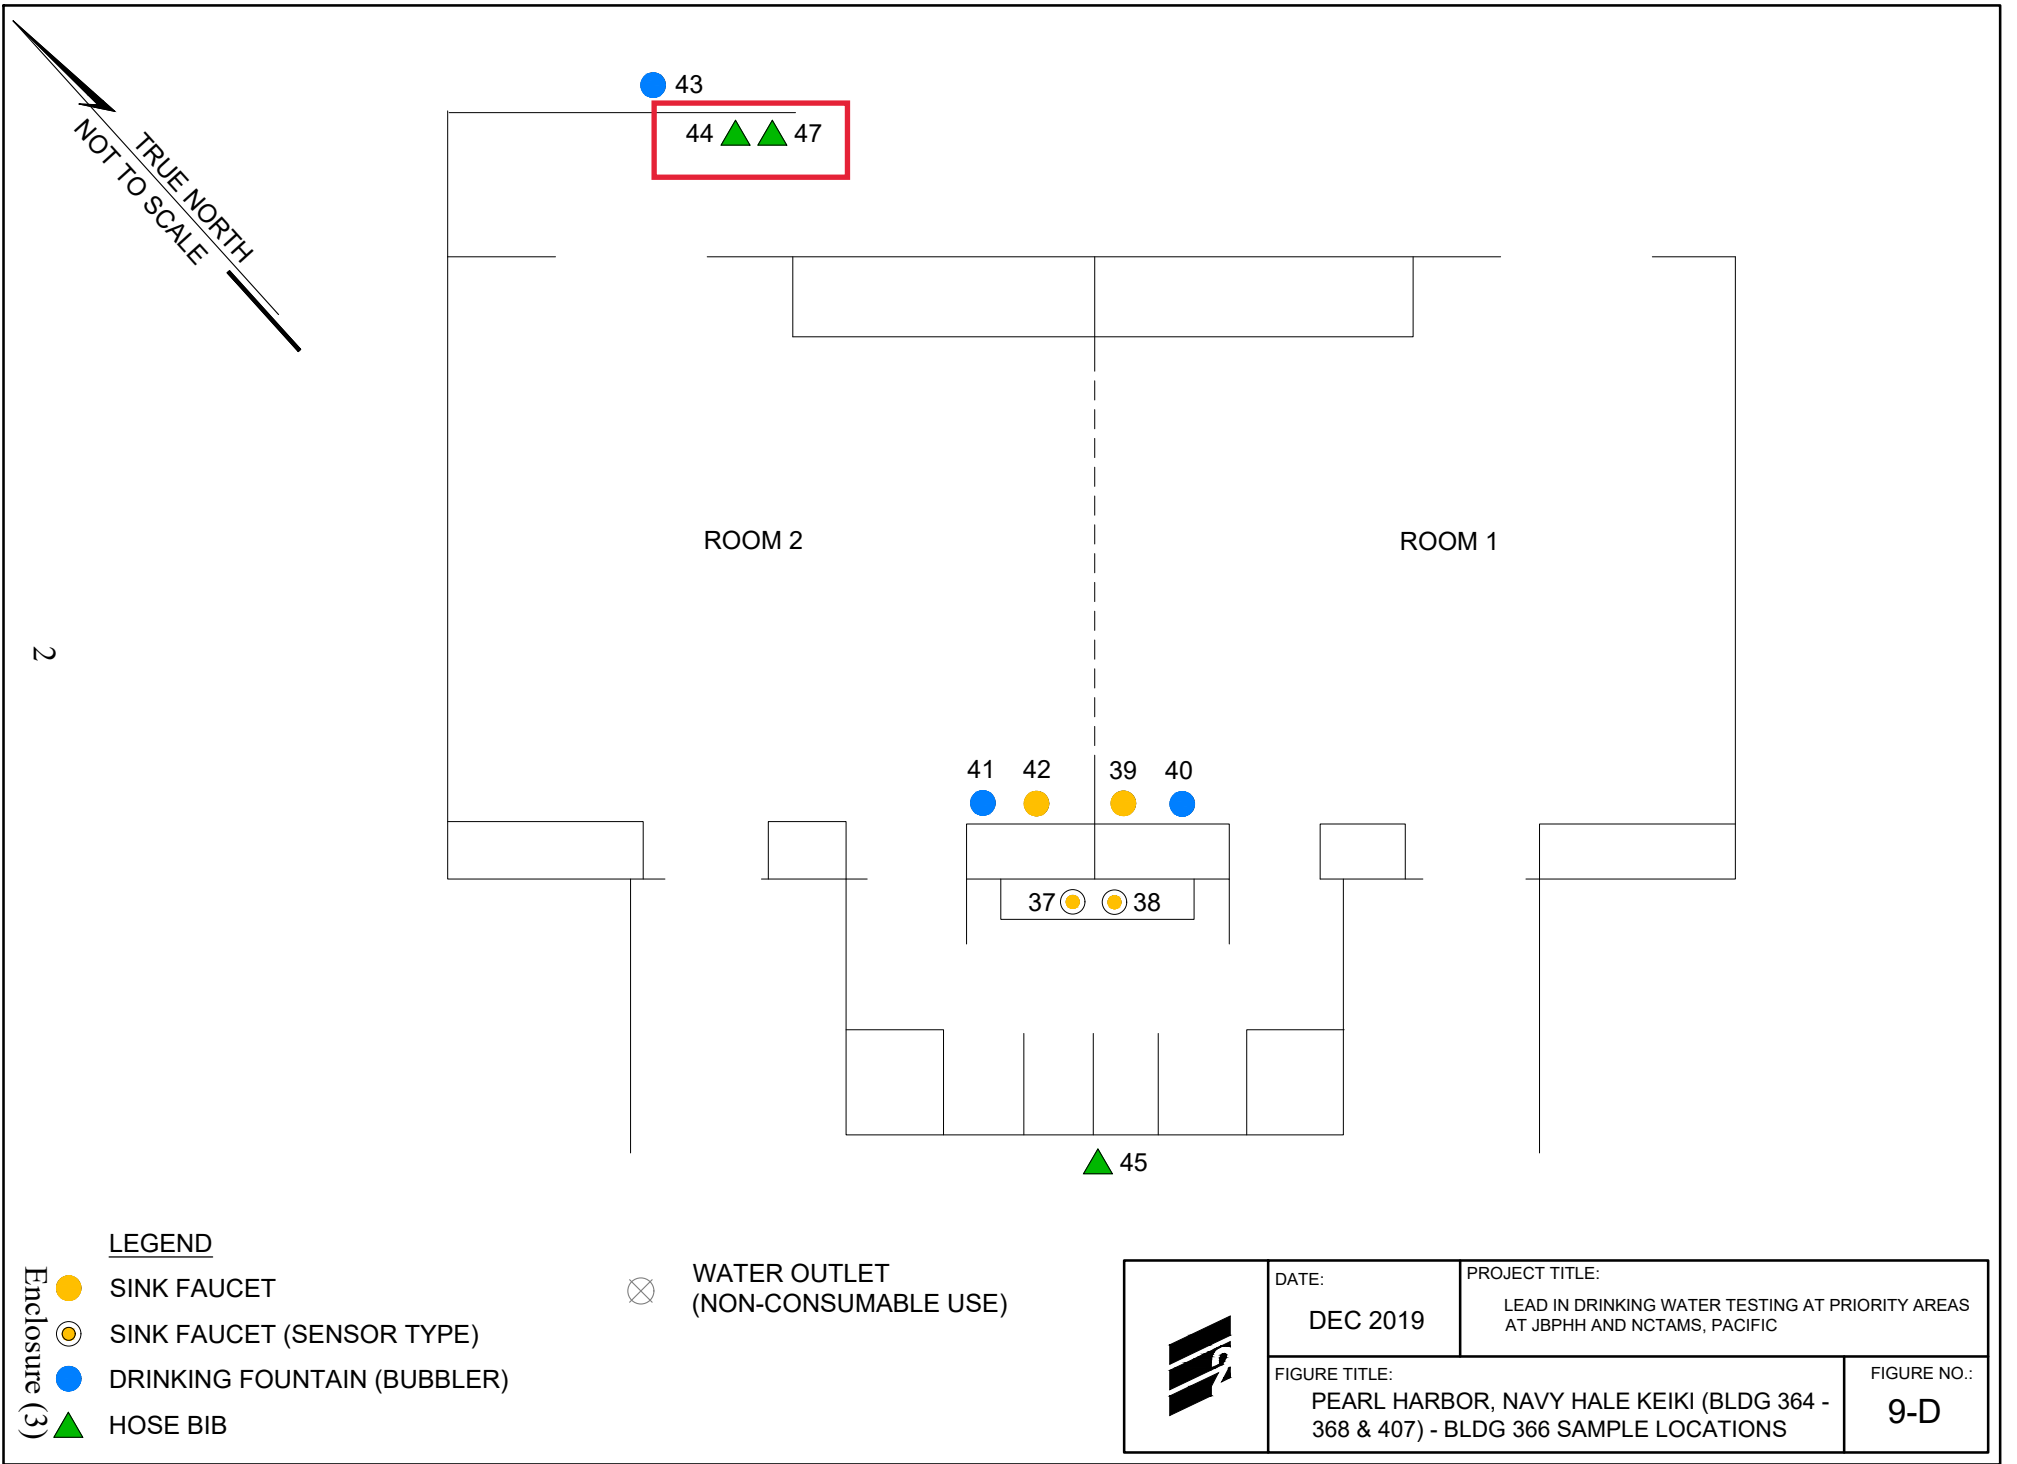
Enclosure (3)

A complete summary results table (enclosure 2) is enclosed for your information. The *Building #* and *Room #* indicate the location of the fixture. The *Outlet Map #* corresponds to the location indicated on the floor plan of the CDC (enclosure 3). The *Category* column gives information about whether the outlet is used for drinking water (water fountain), cooking (food preparation), or washing (primarily hand-washing or brushing teeth). The *Outlet Description* column contains additional information to describe the outlet. The next set of columns provide *Initial Lead Results*, and for those locations that exceeded the recommended screening level of 15 ppb the *Follow-up Lead Results*.
