Quality Validation Plan Addendum

Red Hill Tank Cleaning Verification

Tank Cleaning Verification Procedures

This document section outlines validation procedures for Tank Cleaning Verification at Red Hill Bulk Fuel Storage Facility, to accompany the Department of Navy's Red Hill Closure Plan (Nov 2022), Supplement #1 (Feb 2023) and Supplement #2 (May 2023).

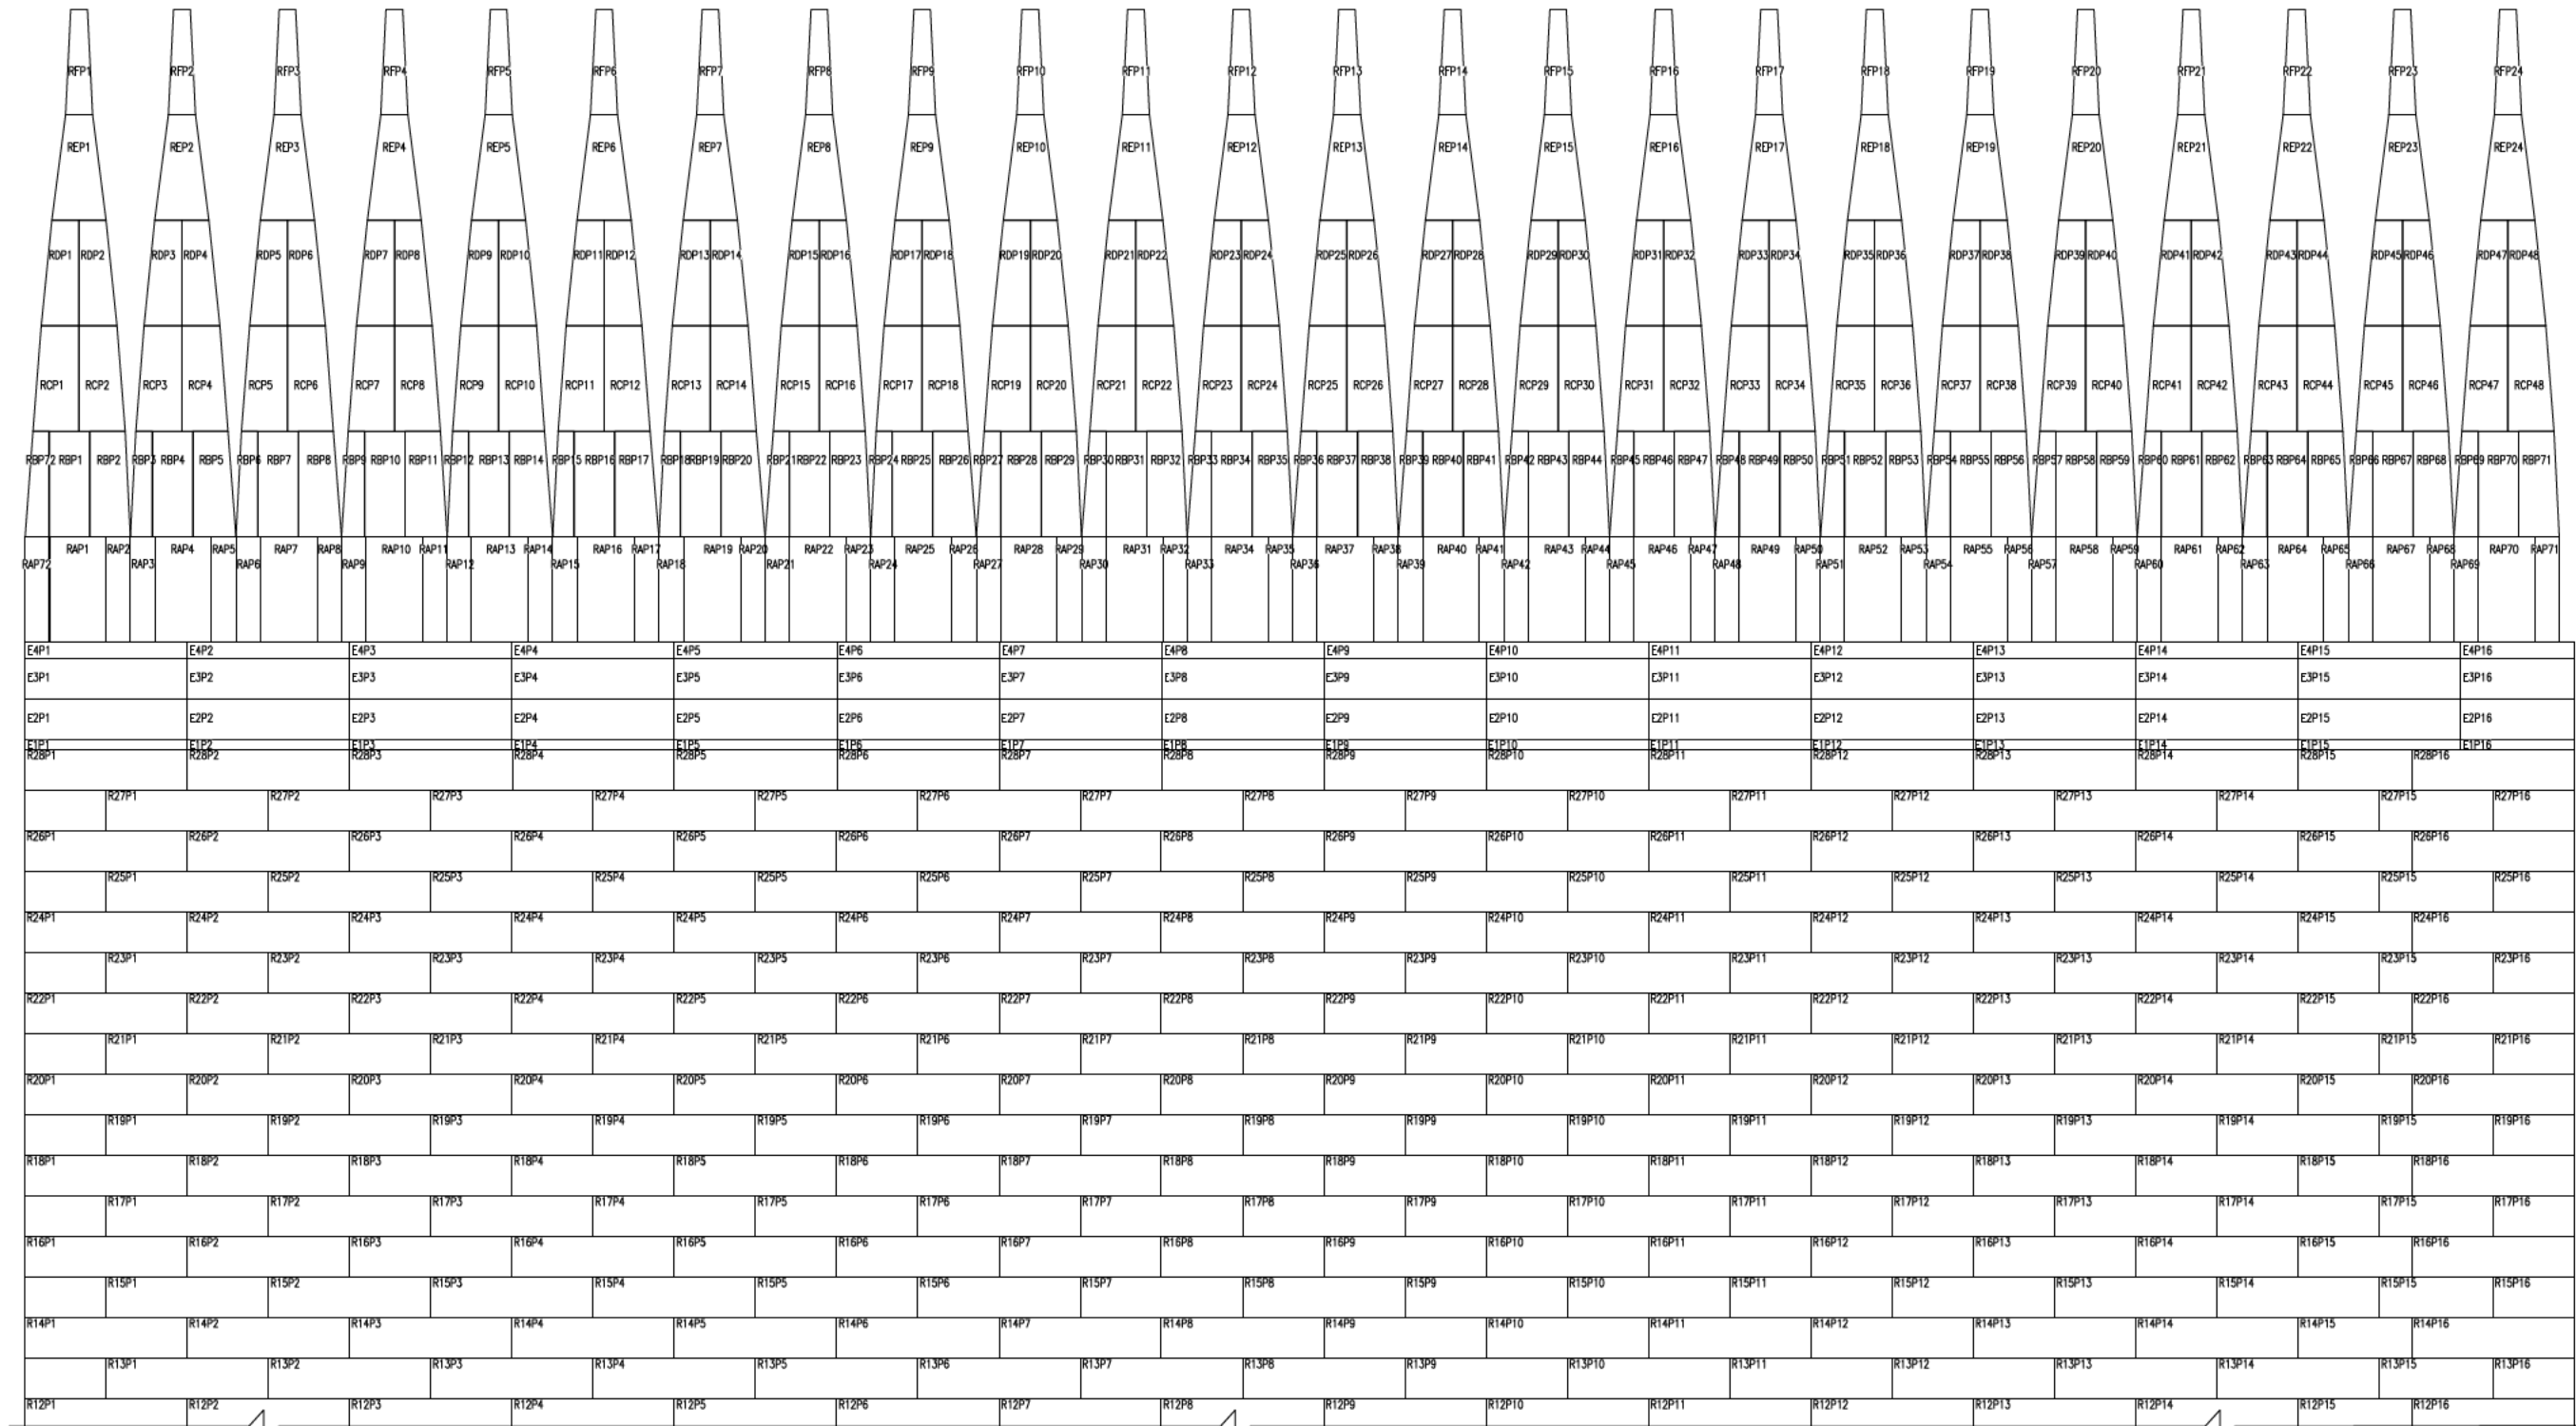
TOP of TANK - SHELL ROLL-OUT

PLATE LAYOUT

As part of the Daily Reporting and QC process, the contractor will utilize a shell roll-out drawing to track plates that have been washed to ensure 100% of the tank interior is cleaned to the agreed

standard. Locations and dates of QC actions or verification samples will be added to the roll-out drawing to track progress and facilitate reporting.

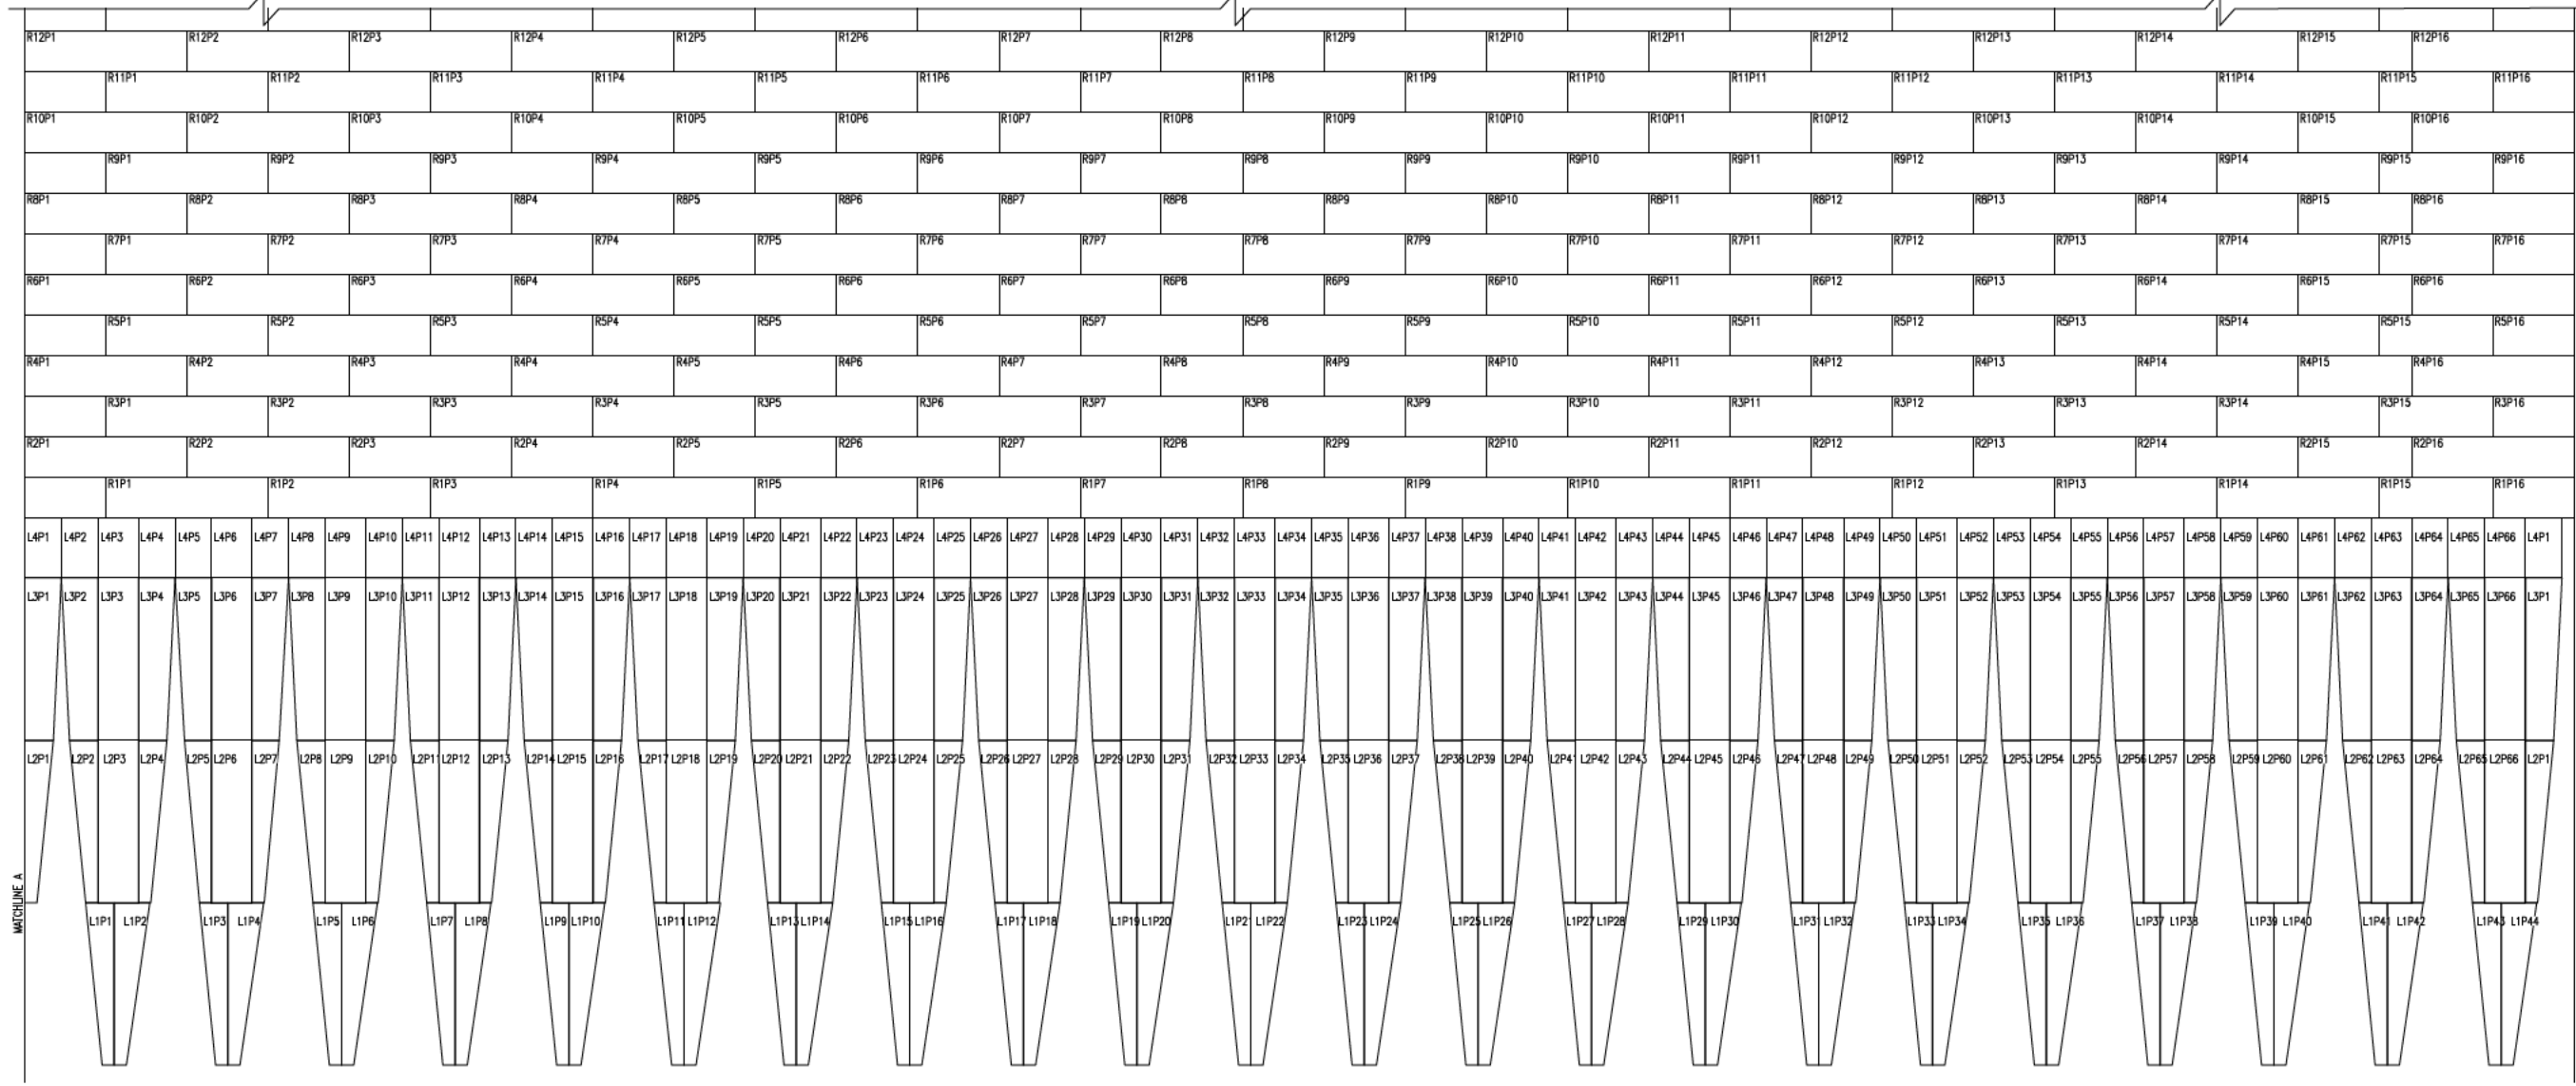
BOTTOM of TANK - SHELL ROLL-OUT

PLATE LAYOUT
