# Tank 5 HISTORY

Poster Station #2  
3 Posters  
March 14, 2018

## ***Tank 5 Fuel Release Was Caused By Human Error, Not Corrosion***

### **TANK 5 RELEASE**

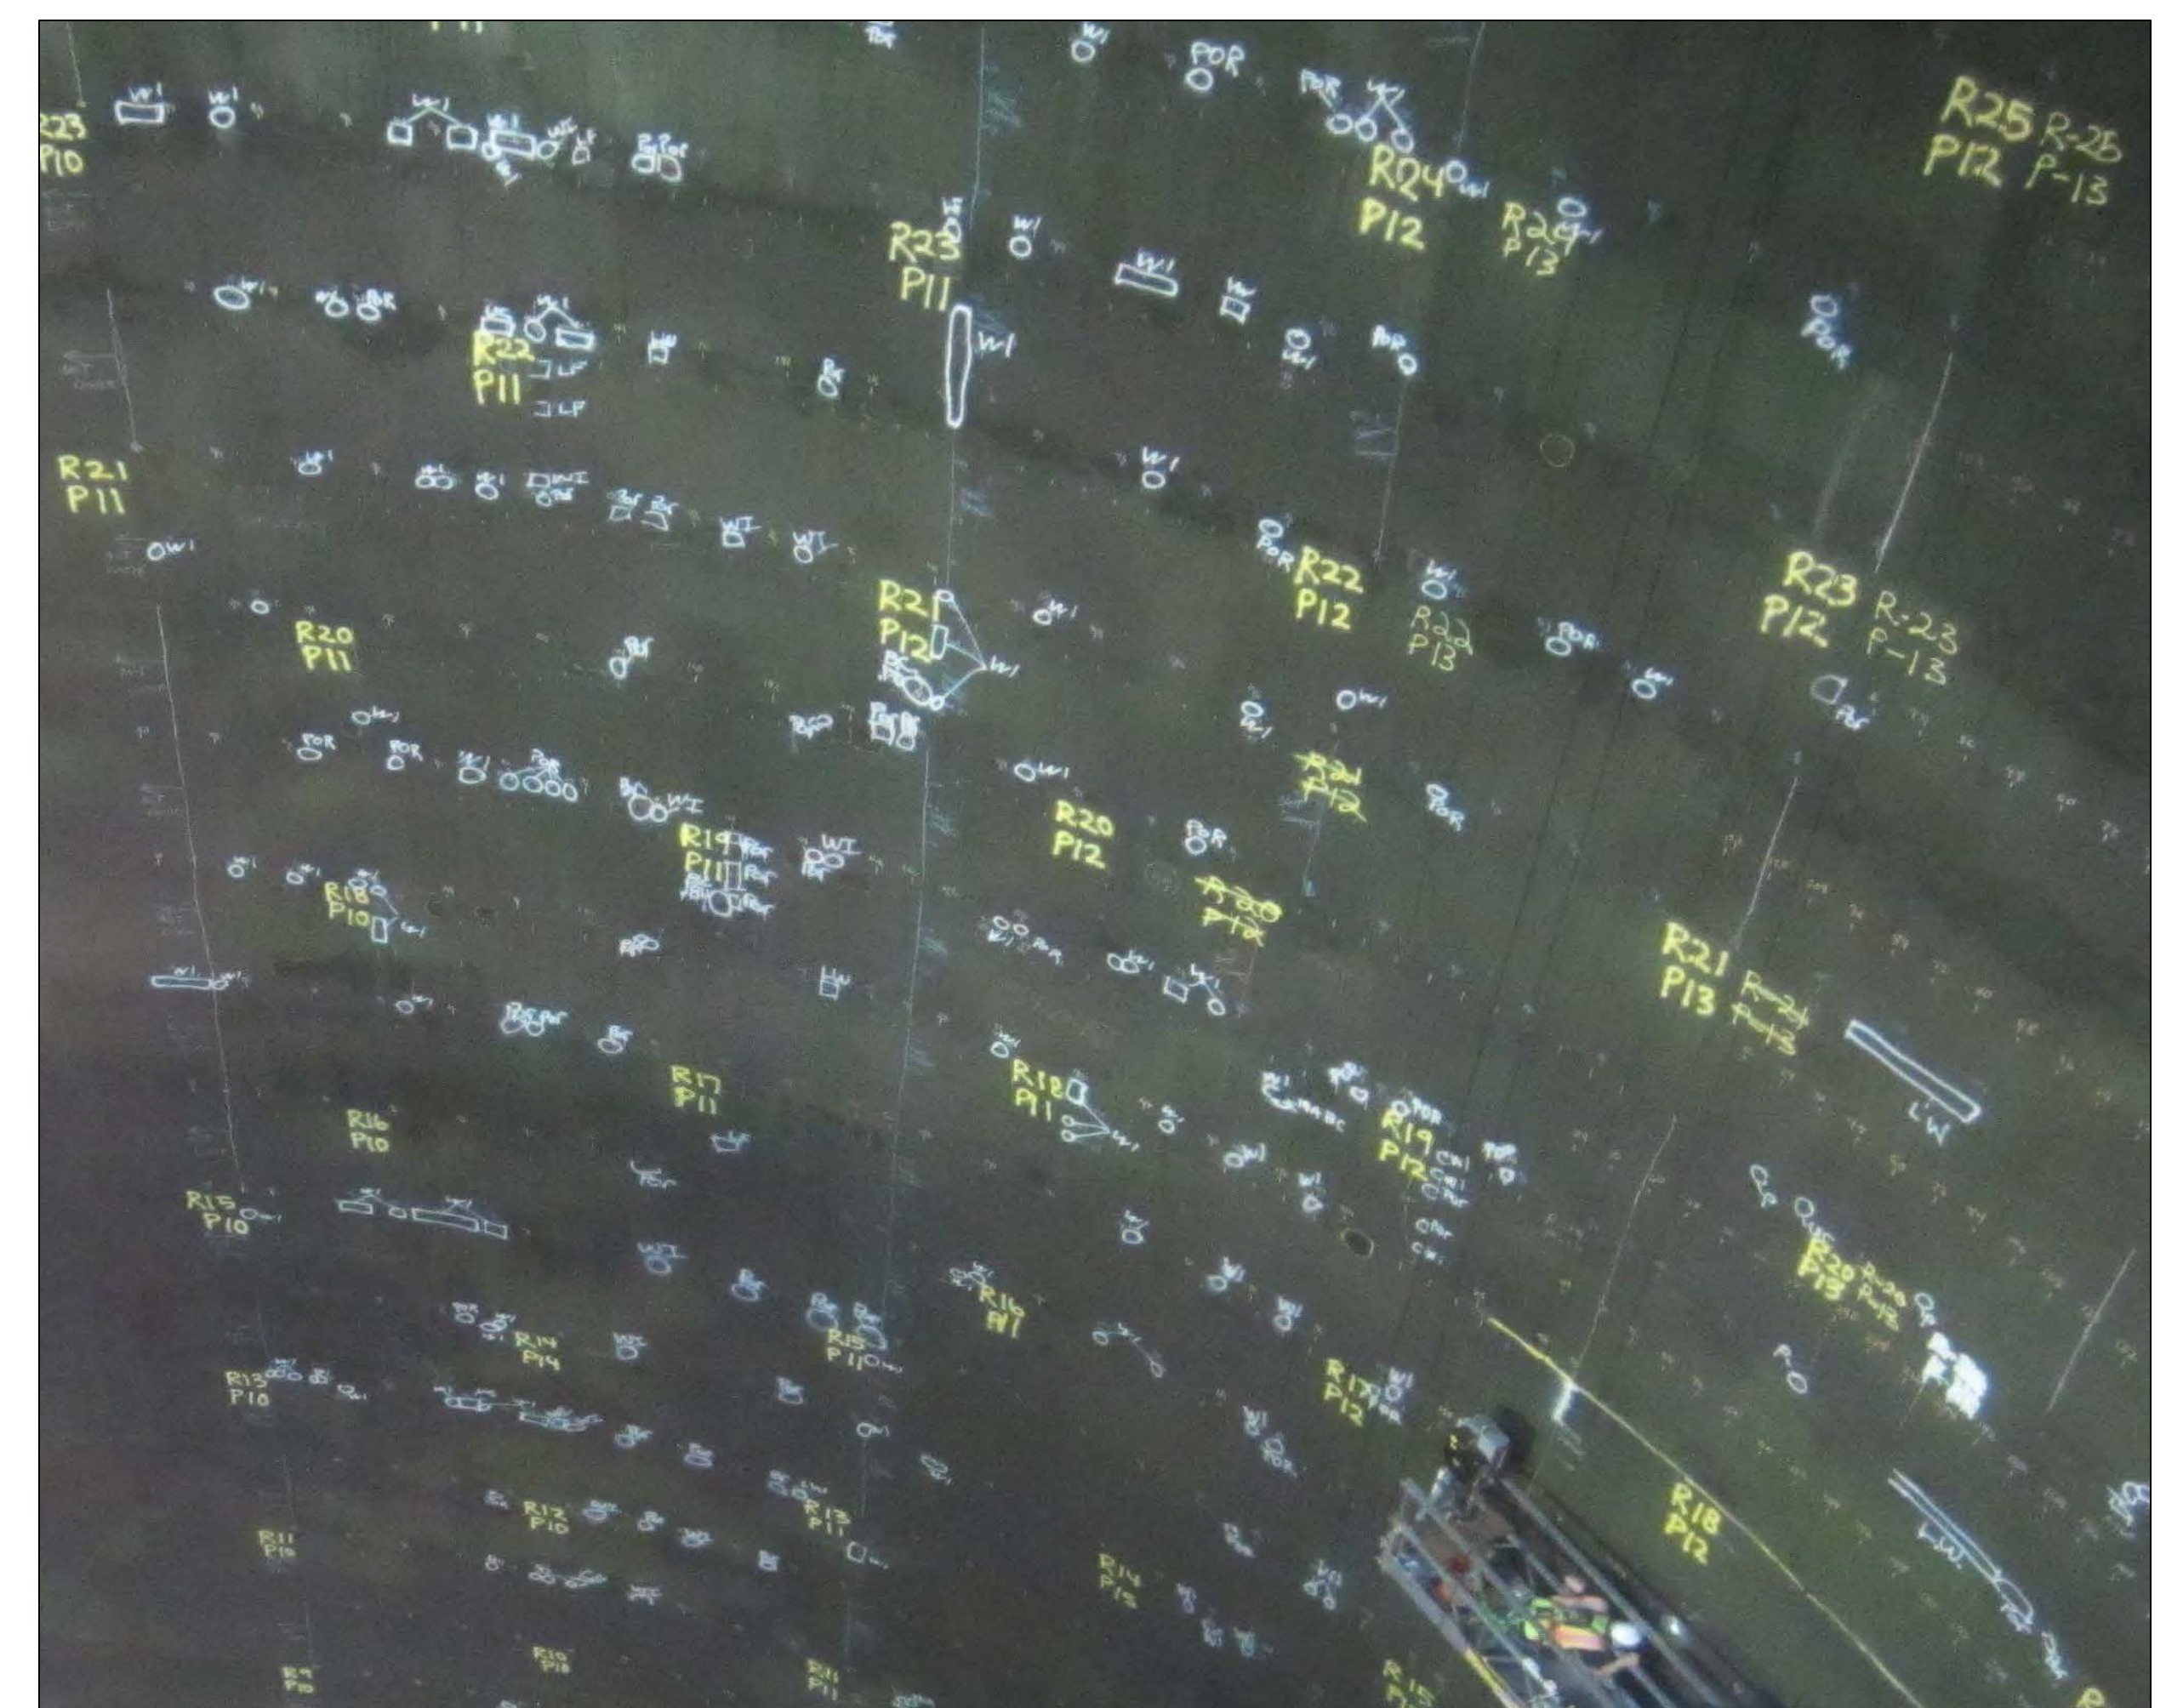
- Tank 5 Passed The Biennial Leak Detection Test 29 June 2009, No Leaks
- Tank 5 Defueled For a Three-year Inspection and Repair Project, 1 Oct 2009
- Contractor Improperly Repaired Tank 5
- An API Inspector Certified Tank 5 Suitable for Service
- Navy Detected a Discrepancy, “Unscheduled Fuel Movement” 12 Jan 2014
- Release Was Reported To Regulators 13 Jan 2014

- Poor Workmanship – Defective Welding Was Ineffective
- Contractor Quality Control
- Insufficient Navy Quality Assurance
- Tank 5 Was Incorrectly Certified “Suitable for Service”
- Government Failed To Acknowledge Alarms While Filling Tank

- Development of Tank Inspection and Tank Repair Specifications
  - Requires Improved Contractor Quality Control
  - Improved Standard of Care for Inspection and Repair
- Improved Navy Quality Assurance Process
- New Filling and Return to Service Instruction
- Tank 5 Was Completely Reinspected in 2017
