Subj: SAMPLING AND TESTING FOR LEAD IN DRINKING WATER AT CENTER DRIVE CHILD DEVELOPMENT CENTER

Overview of Testing Results and Corrective Actions for Center Drive CDC (Building 930)

LIPA Test Results
JBPHH - Center Drive CDC (Building # 930)

DATE: NOV 2019	PROJECT TITLE: LEAD IN DRINKING WATER TESTING AT PRIORITY AREAS AT JBPHH AND NCTAMS, PACIFIC
	FIGURE TITLE: PEARL HARBOR, CENTER DRIVE CDC (BLDG 930) - OVERALL FACILITY MAP

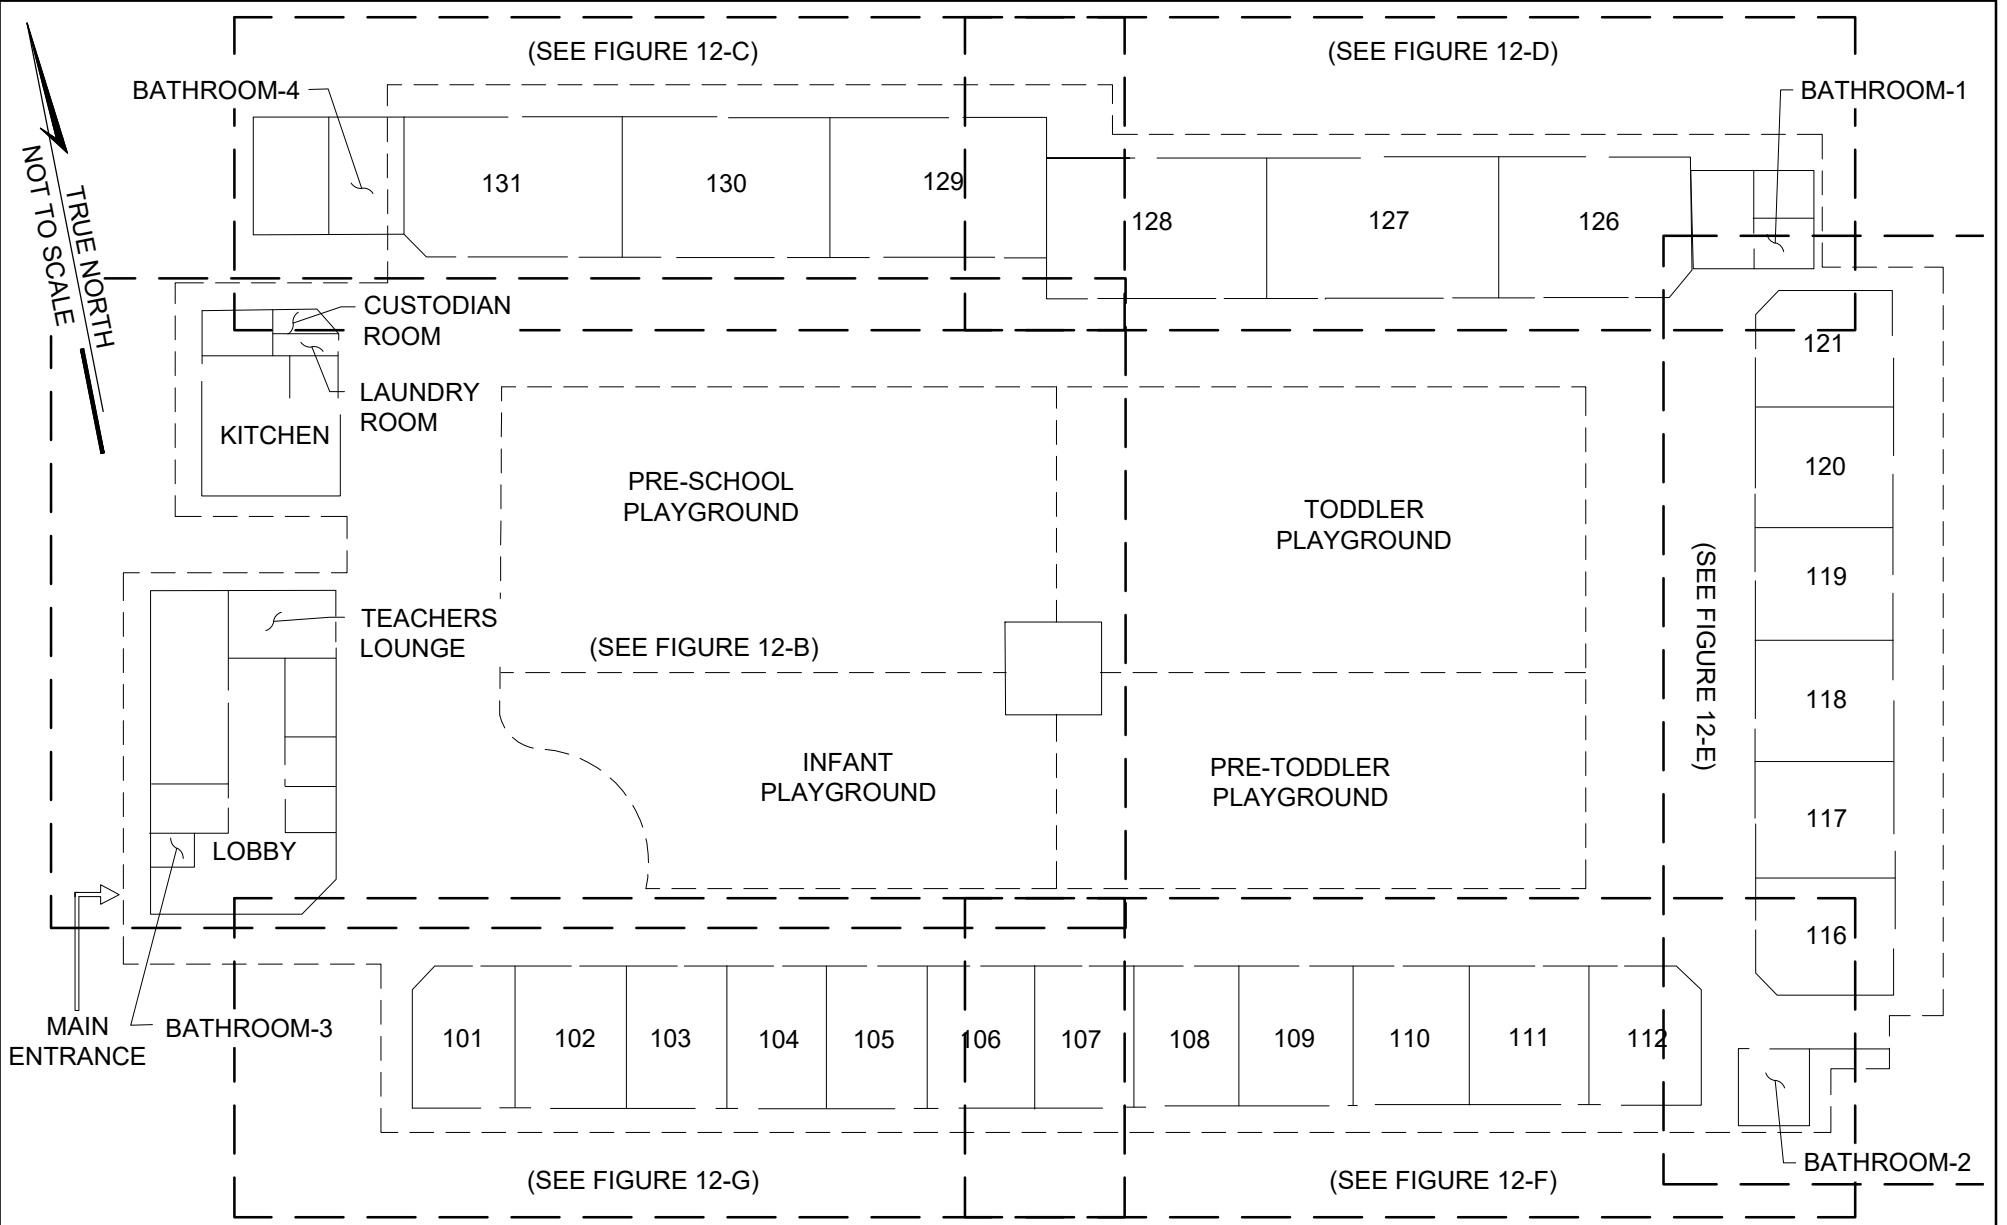
A complete summary results table (enclosure 2) is enclosed for your information. The *Building #* and *Room #* indicate the location of the fixture. The *Outlet Map #* corresponds to the location indicated on the floor plan of the CDC (enclosure 3). The *Category* column gives information about whether the outlet is used for drinking water (water fountain), cooking (food preparation), or washing (primarily hand-washing or brushing teeth). The *Outlet Description* column contains additional information to describe the outlet. The next set of columns provide *Initial Lead Results*, and for those locations that exceeded the recommended screening level of 15 ppb the *Follow-up Lead Results*.

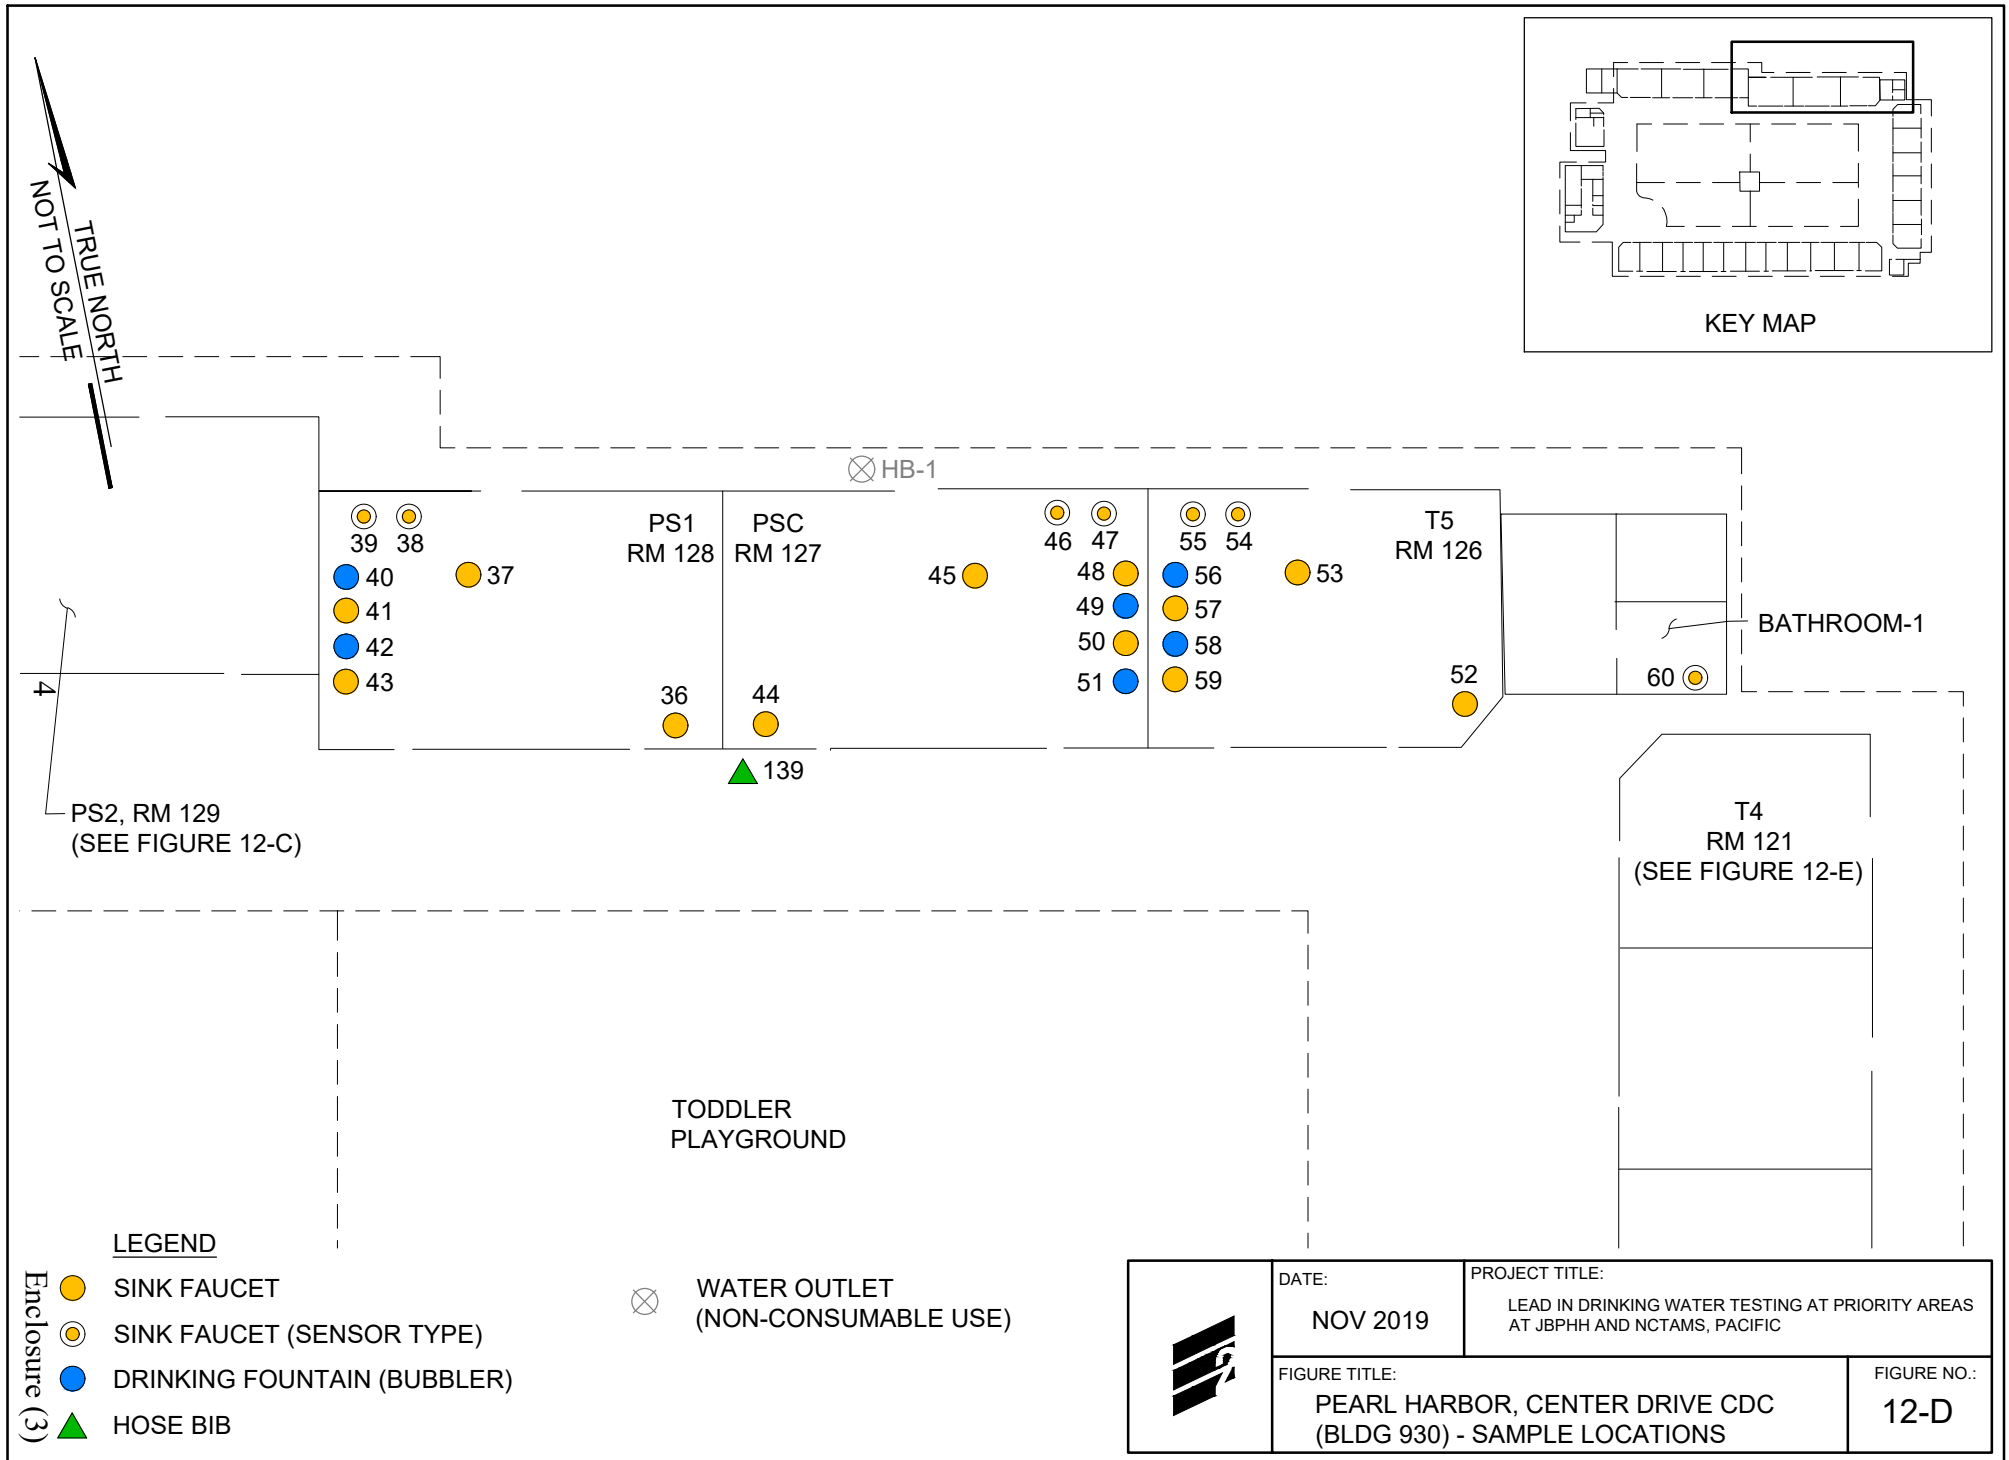
DATE: NOV 2019	PROJECT TITLE: LEAD IN DRINKING WATER TESTING AT PRIORITY AREAS AT JBPHH AND NCTAMS, PACIFIC
	FIGURE TITLE: PEARL HARBOR, CENTER DRIVE CDC (BLDG 930) - SAMPLE LOCATIONS

T5, RM 126
(SEE FIGURE 12-D)

PT1
RM 112
(SEE
FIGURE 12-F)

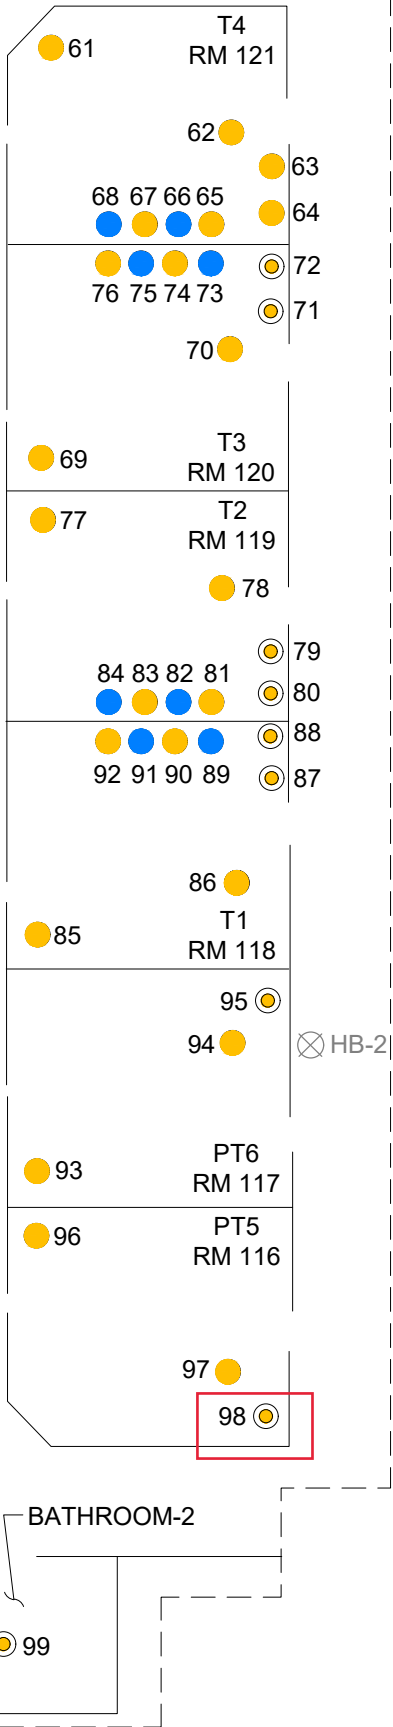
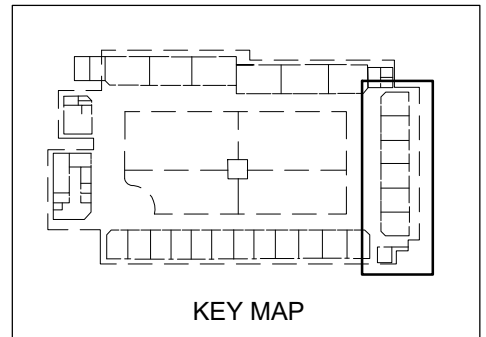
140 ▲
